FACILITY ASSESSMENT REPORT

*MONTICELLO
COMMUNITY SCHOOL
DISTRICT*

FEH Associates Inc.
Architecture | Structural Engineering | Interiors

Monticello Community School District Facility Assessment

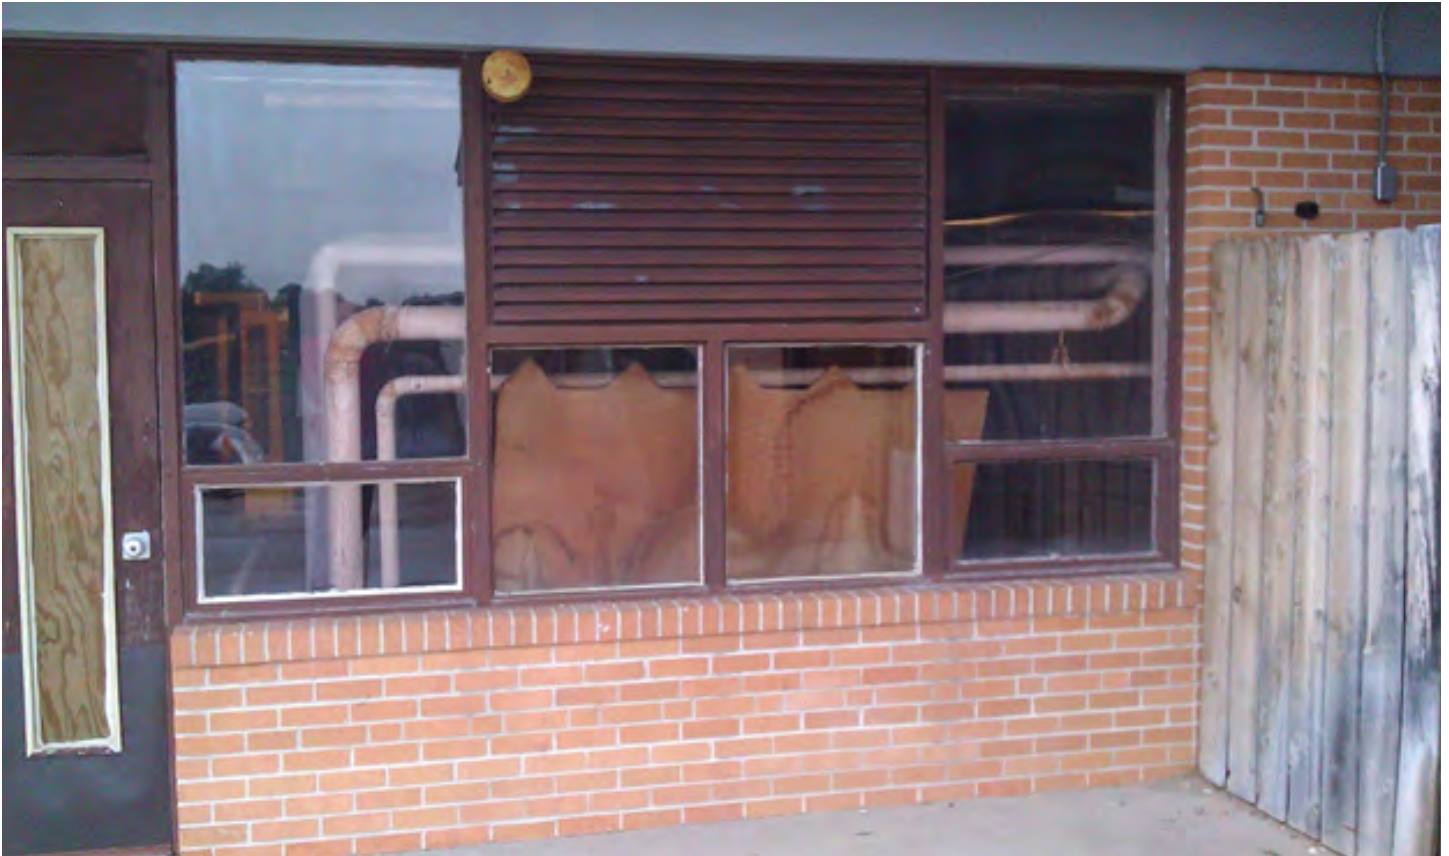
Boiler room windows are single pane glass in steel frames. They should be replaced. (Image is top of next page)

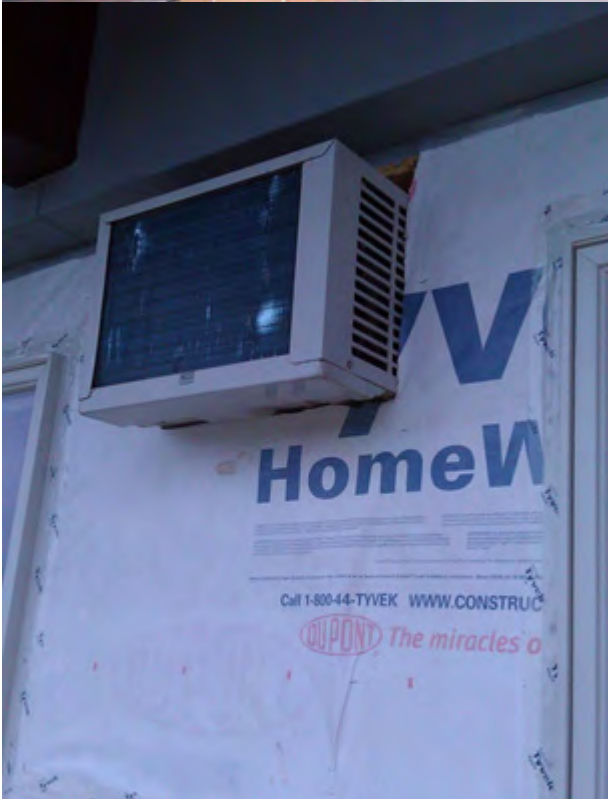
A Tyvek type building wrap is installed in the window replacement area. Wall air conditioning units are cut into the wrap in the wall. Proper termination is required to provide a vapor barrier. (Left image)

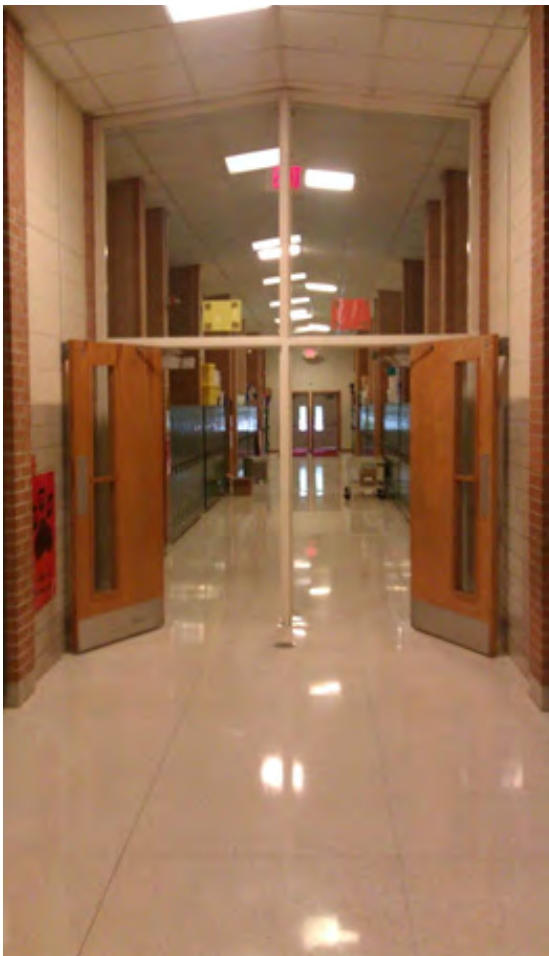
The principal reported that the center mullions on the interior corridor fire doors are a hazard for the small children. They frequently bump into them. (Left image)

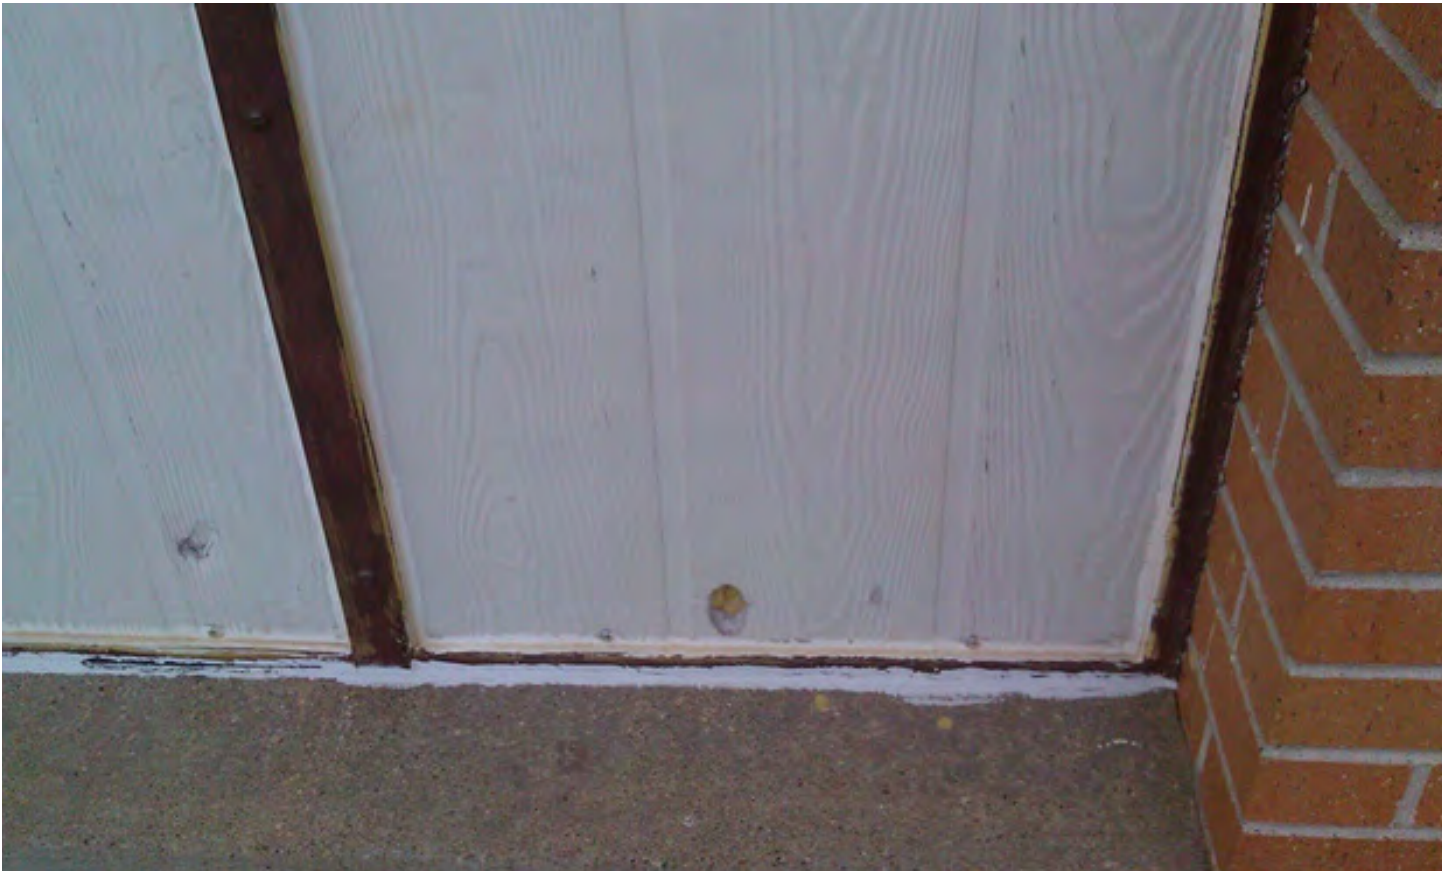
There are insulated panels on the exterior wall of the gymnasium with holes in them. They should be patched or replaced with a material that will withstand abuse. (Above image)

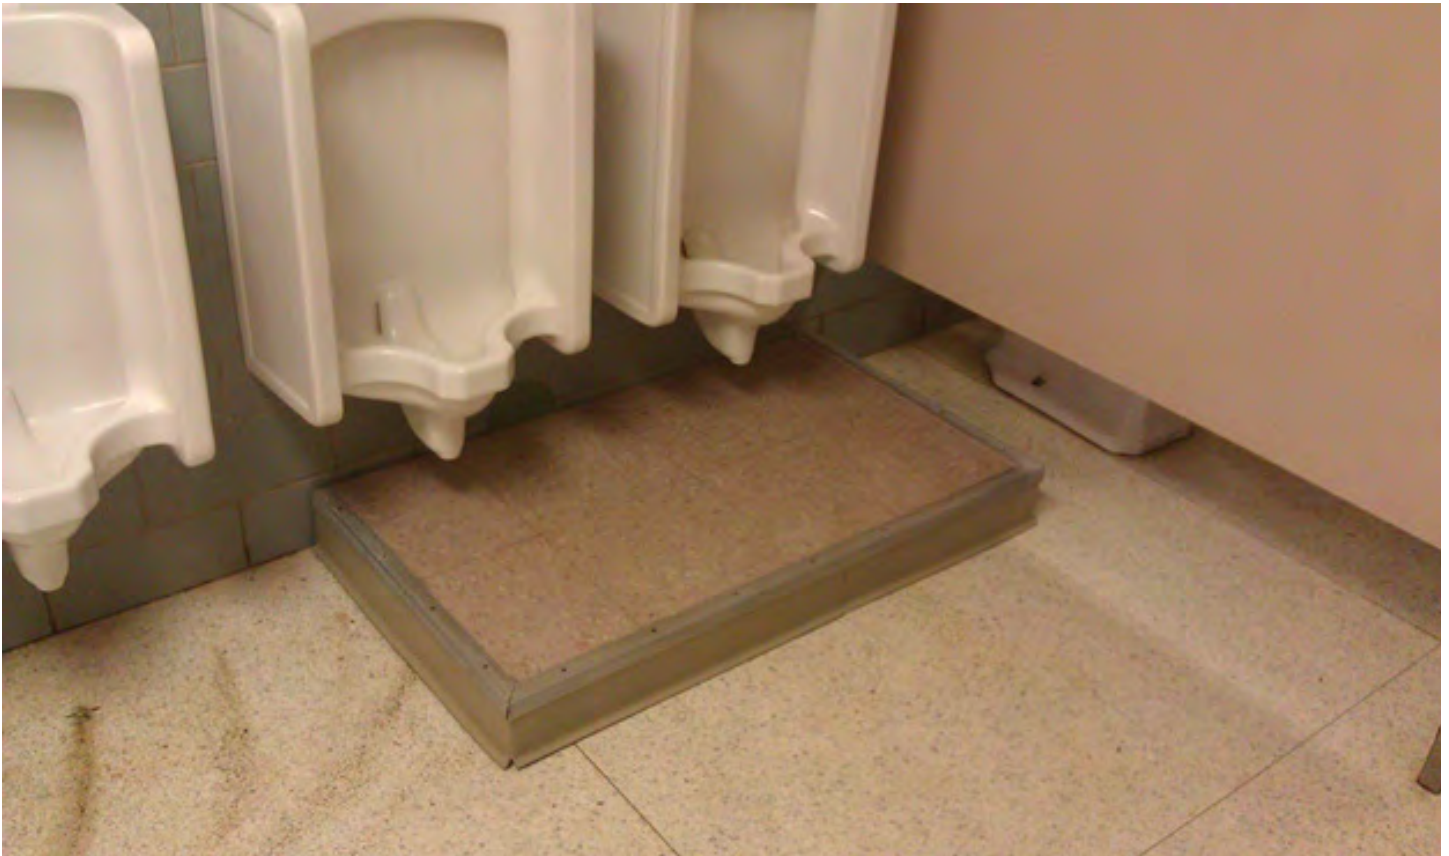
The restrooms in the preschool classrooms and the main restrooms are not ADA compliant. (Above image)

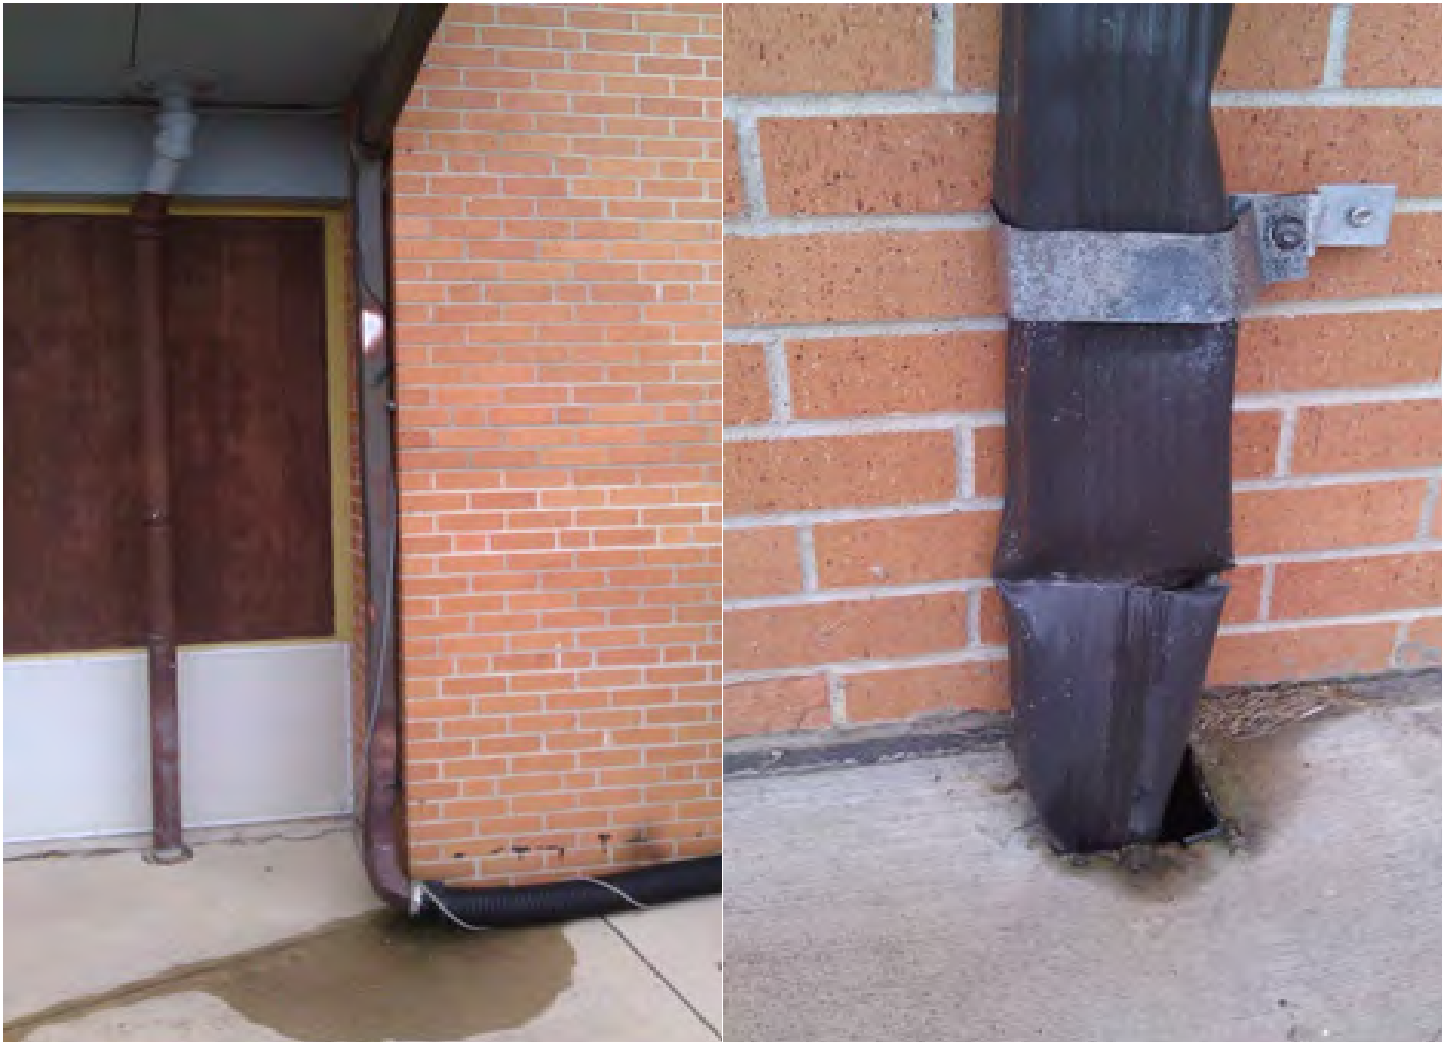
The Downspout at the Southeast corner of the gym is smashed and runs water against the wall. It requires replacement with a more rigid solution that will with stand abuse and Ice. (Above images)

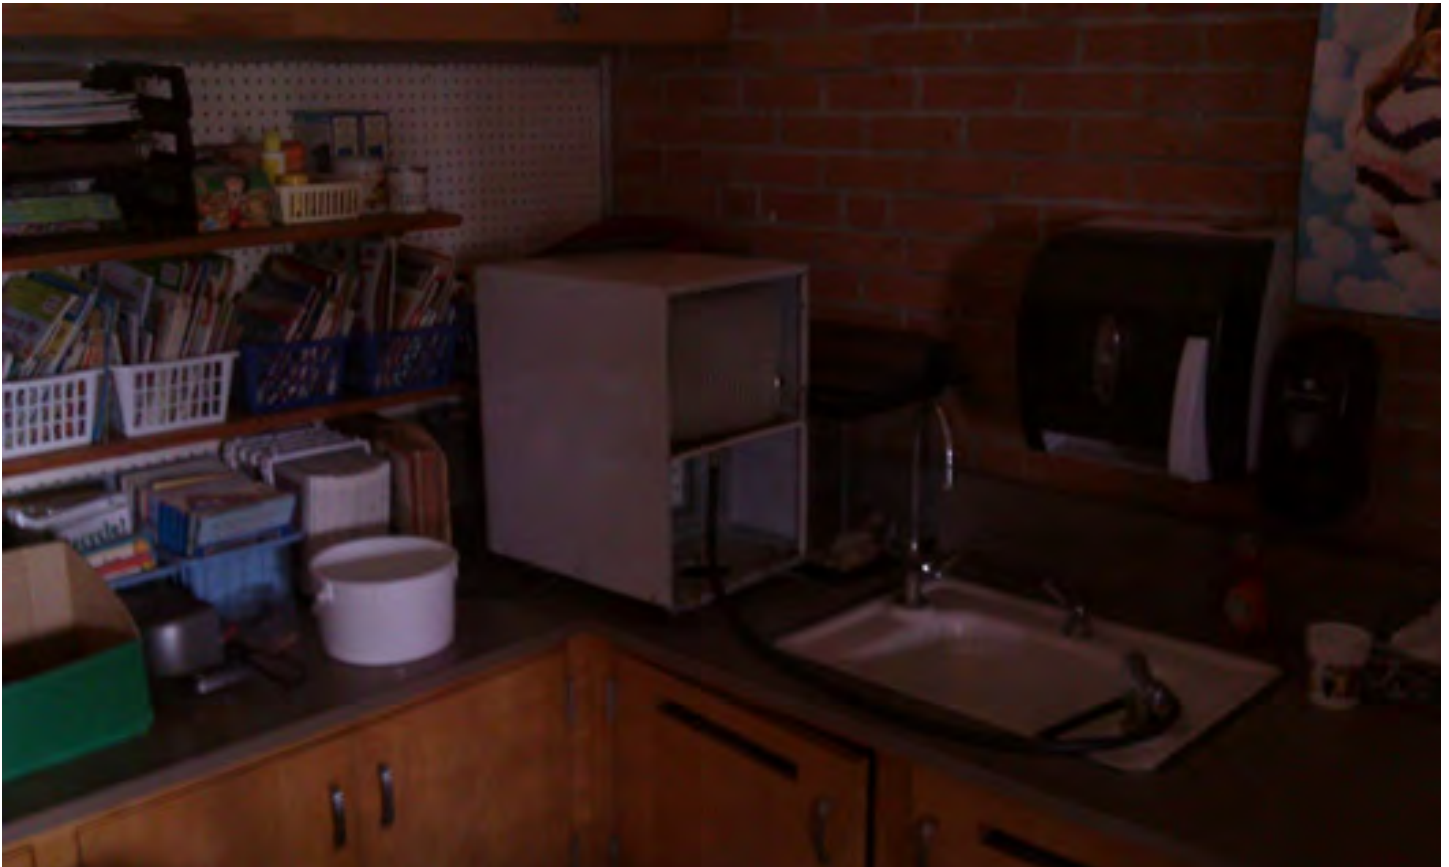
A dehumidifier was draining into the hand washing sink of the Southwest classroom. (Above image)

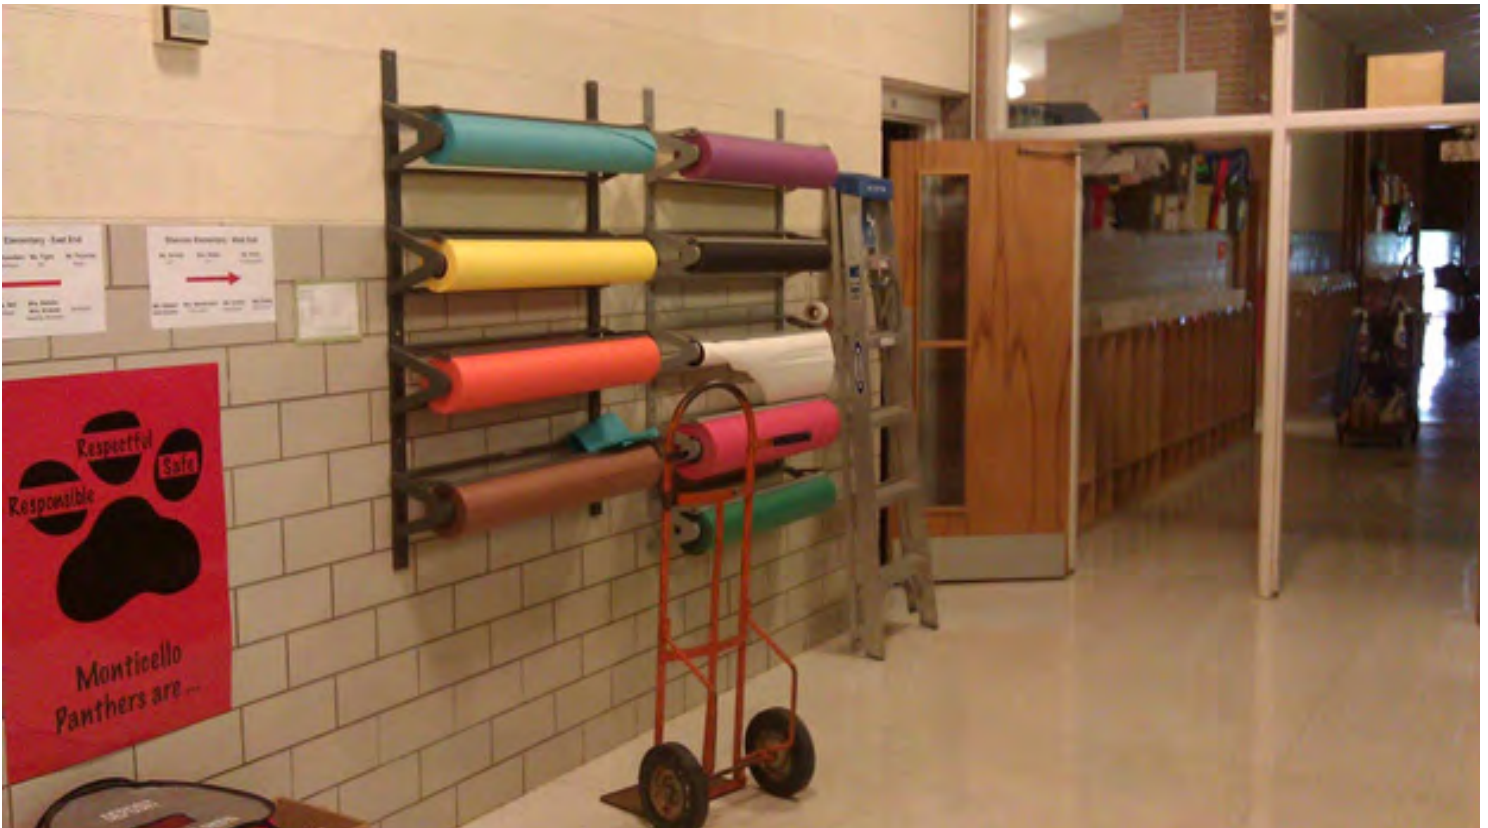
The art paper rolls are mounted on the wall in the exit corridors. (Image below)

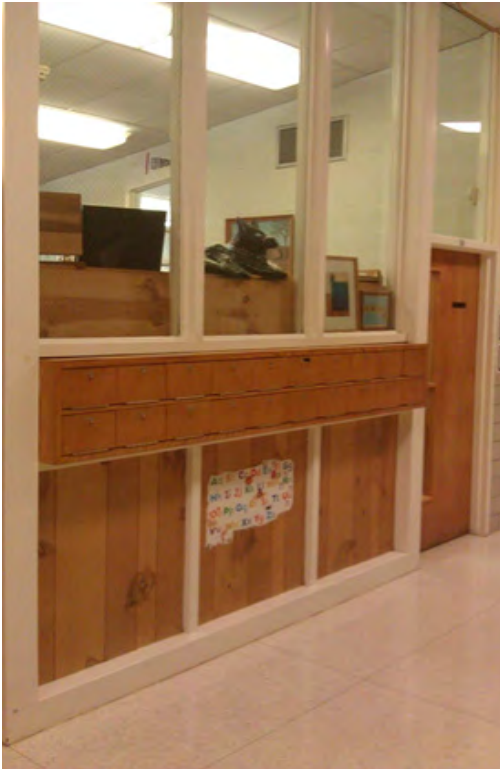
There is a significant amount of wired glass in the corridors. The International Building code no longer allows wired glass in schools. (Left image)

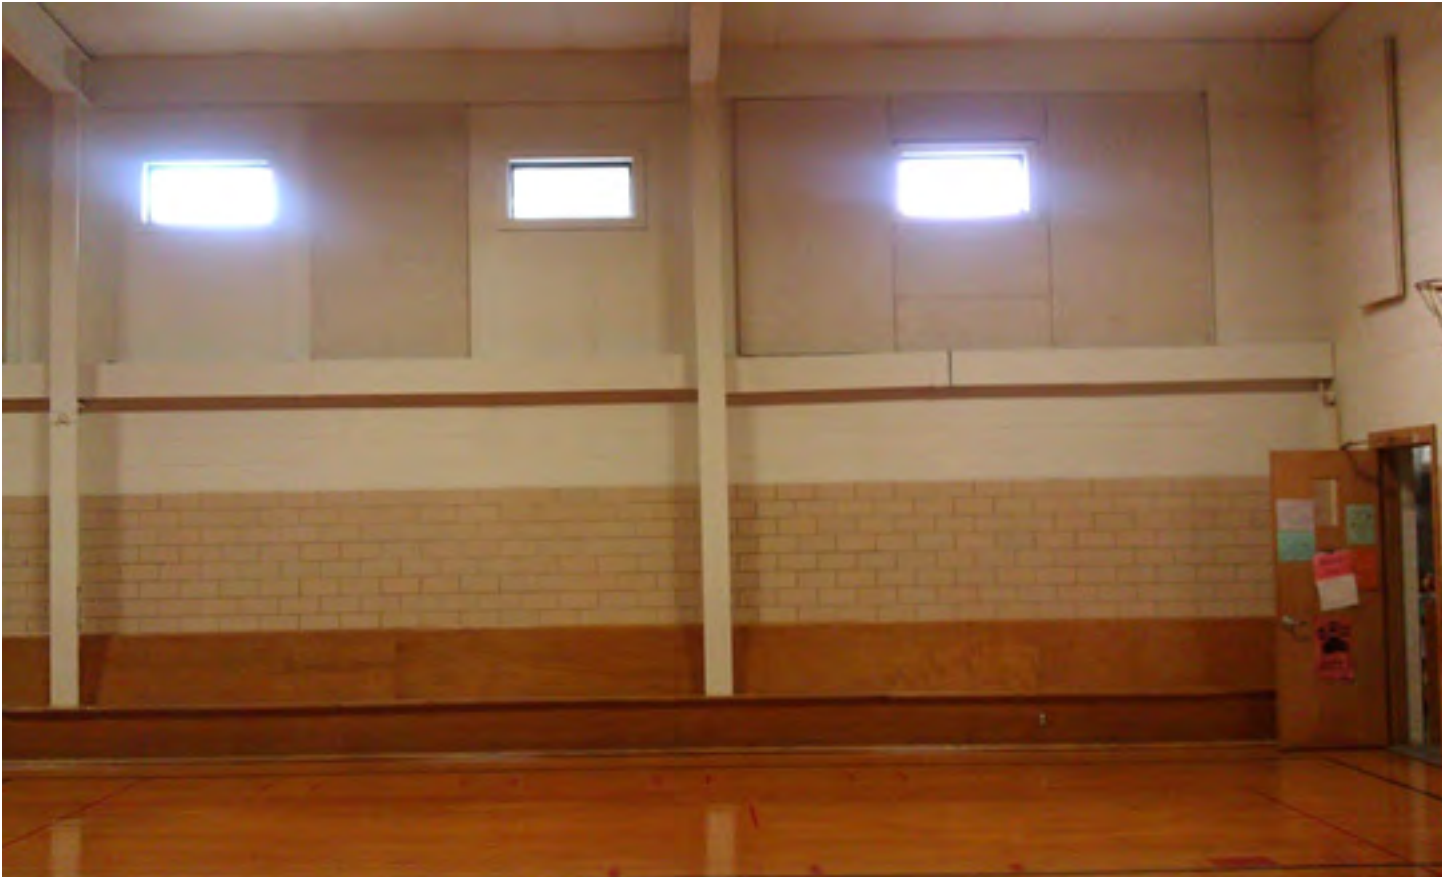
There are 3 clear glass windows into the gymnasium. This can cause glare related accidents and injury. These should be tinted or translucent glazing. (Above image)

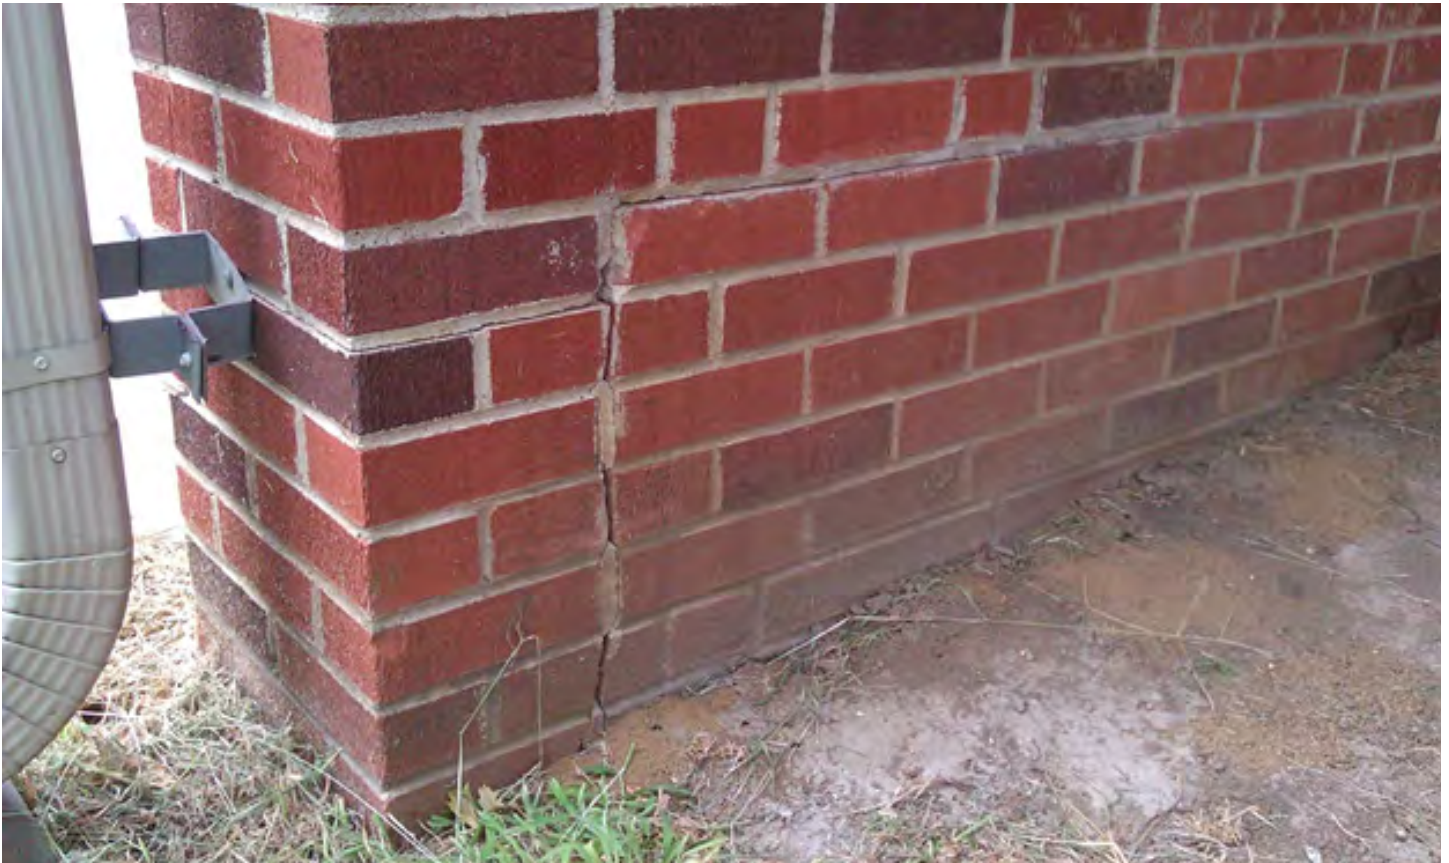
The masonry is in reasonable condition. Interior Masonry appears to be a perforated acoustical glazed tile. Periodic tuckpointing is required in some exterior areas. There is at least one location where settlement cracking has occurred and previous repair has failed. This will require replacement of broken brick and mortar pointing. (Above image)

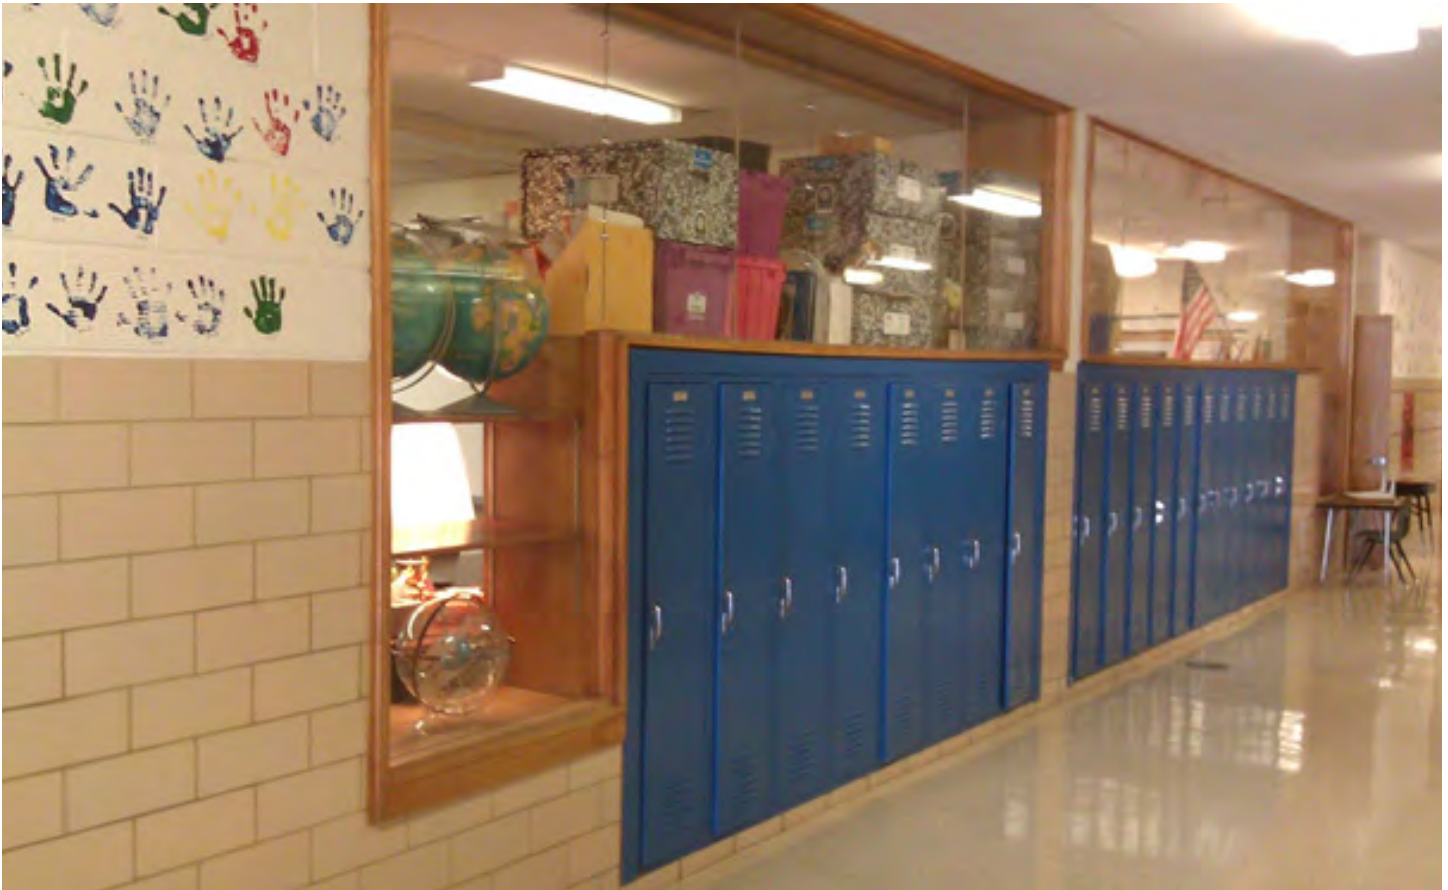
There are large areas of glass from the corridors to the classrooms. While this is very nice for day lighting and creating an open atmosphere, these are required to be fire rated walls. Either a fire sprinkler system needs to be added or these windows need to be replaced with rated construction. (Previous page top image)

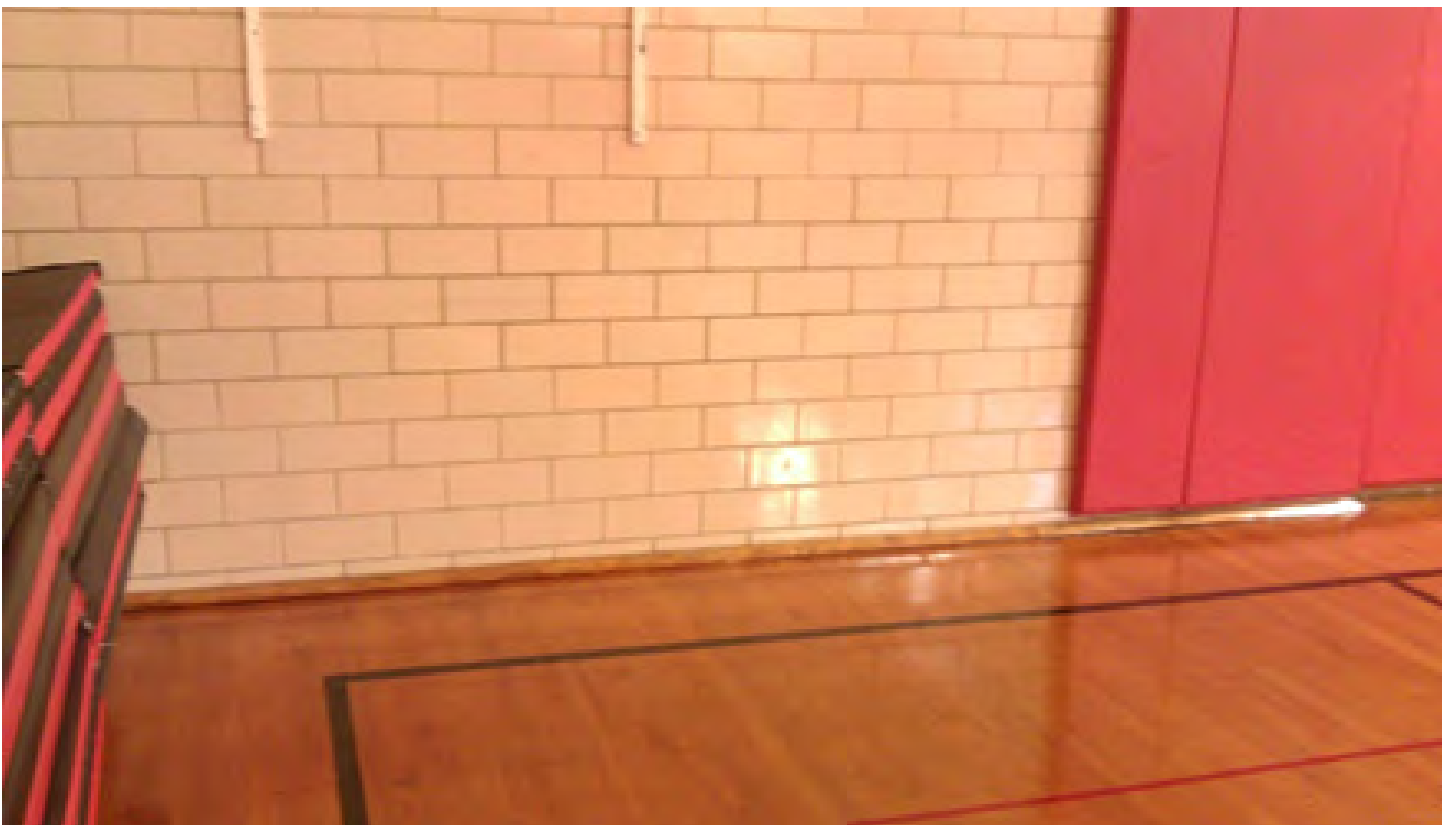
The striped basketball court in the gymnasium only allows 24" from the court to the end walls and the side benches. Insurance standards recommend 10' at end wall from courts and 6' and sides. (Bottom image)

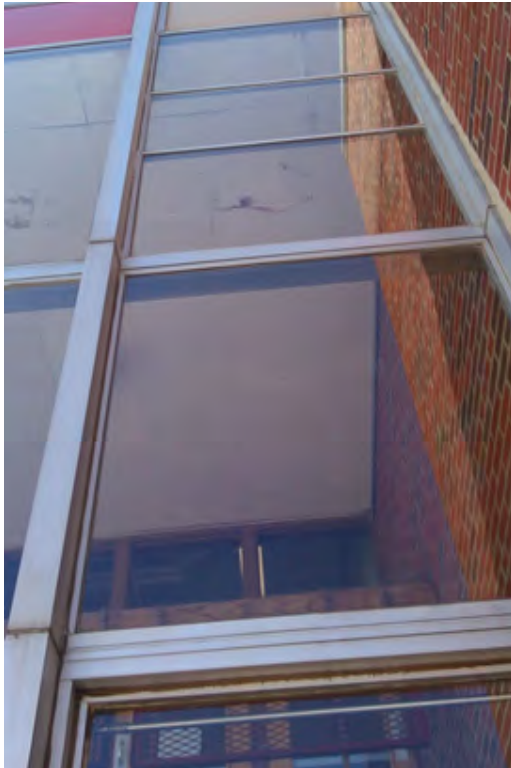
The windows are single pane clear glass in non-thermally broken clear anodized aluminum frames in the newer part of the building. There are also many insulated panels in these frames. (Left image)

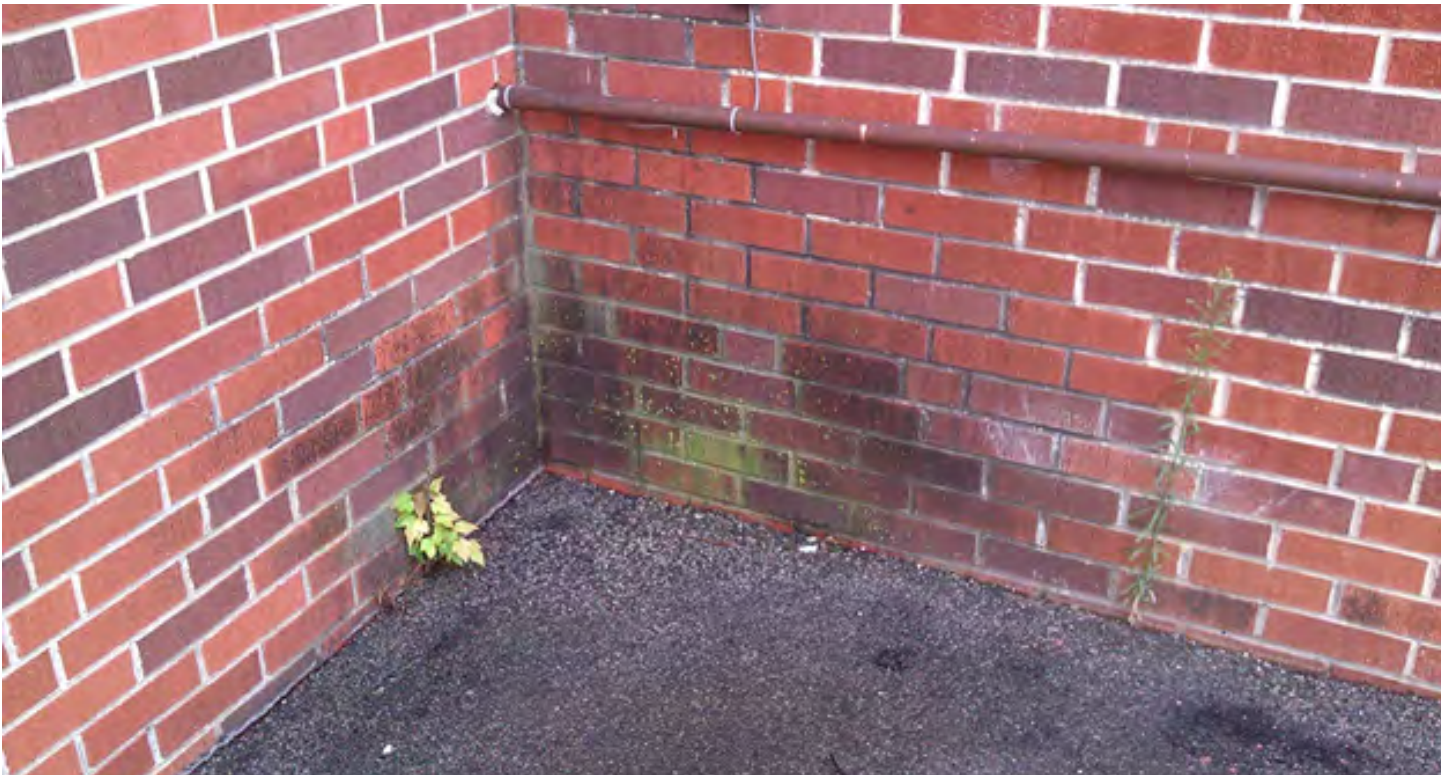
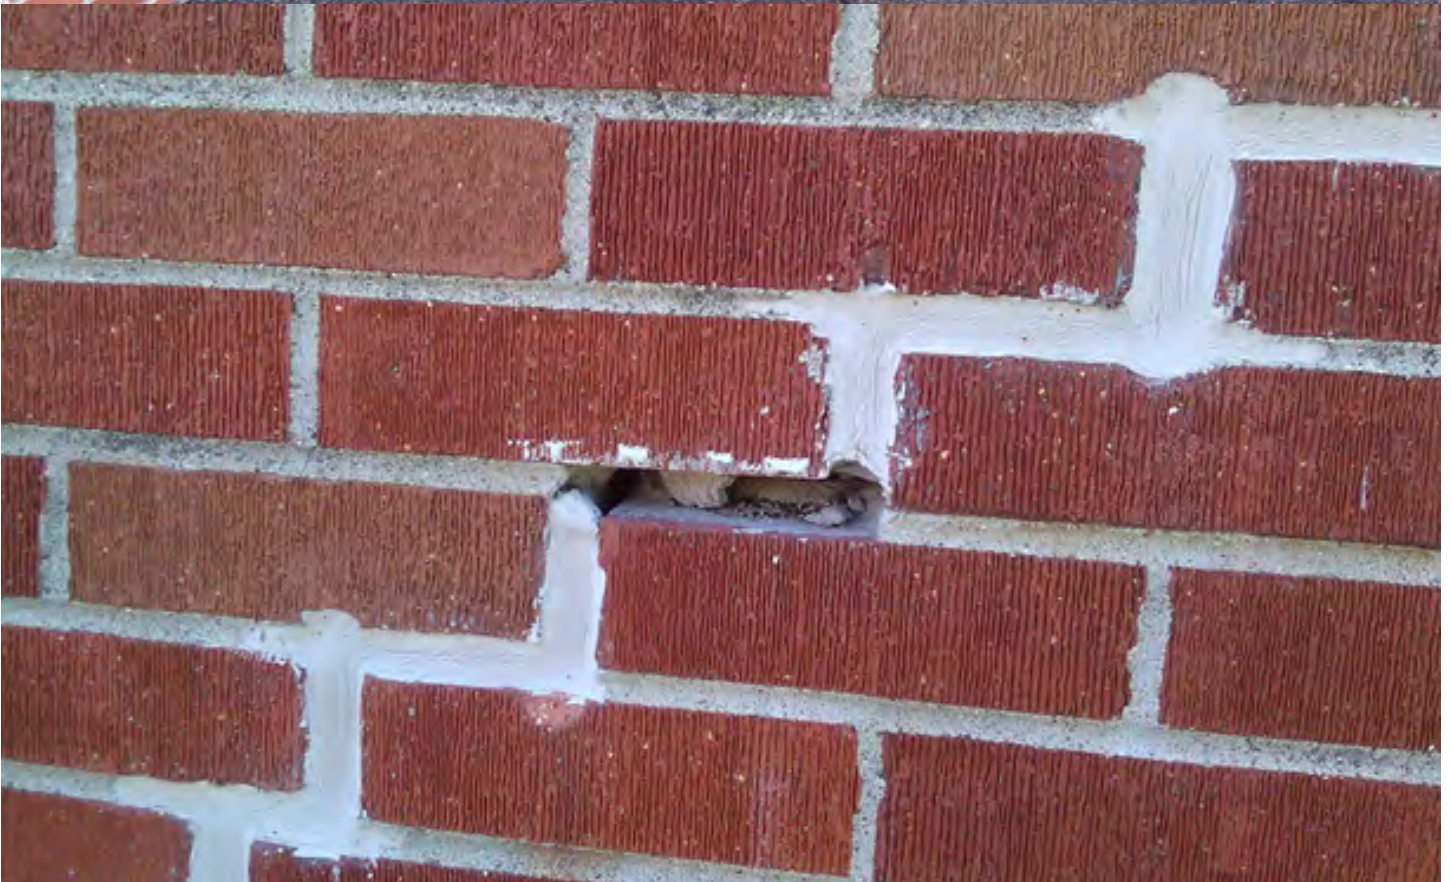
Caulking is dried and missing in many locations. There are locations where caulking has been used instead of proper masonry tuckpointing at cracks and joints in the exterior wall. Window and door sealants need to be replaced. (next page top and bottom images)

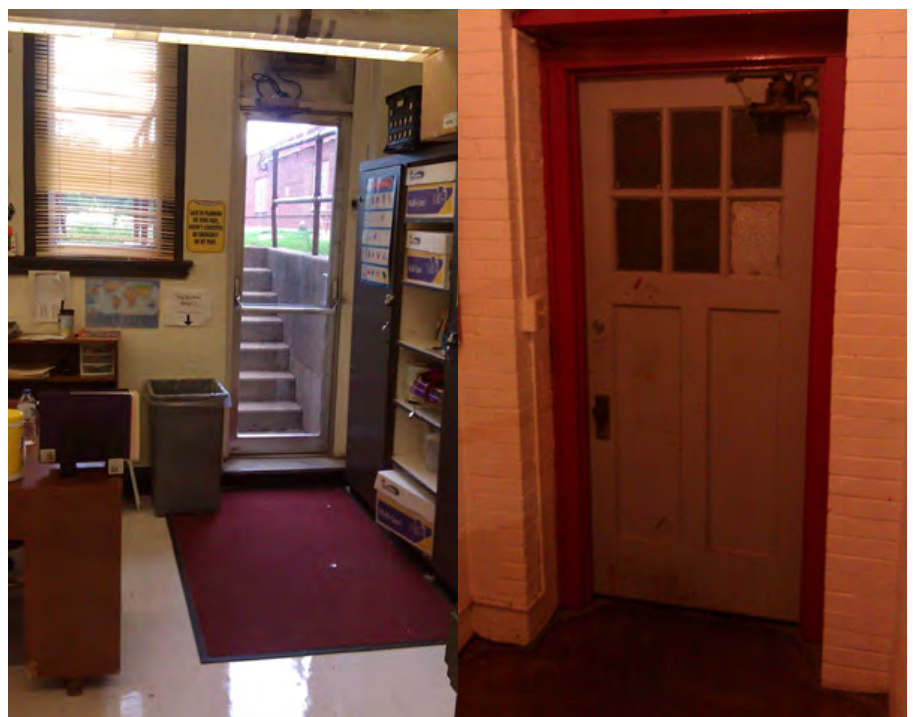
This door to the corridor from the classroom space swings into the corridor and not only reduces the required exit width but also is a hazard for people moving in the corridor. The main entry doors are too narrow to comply with current codes. (Top left image)

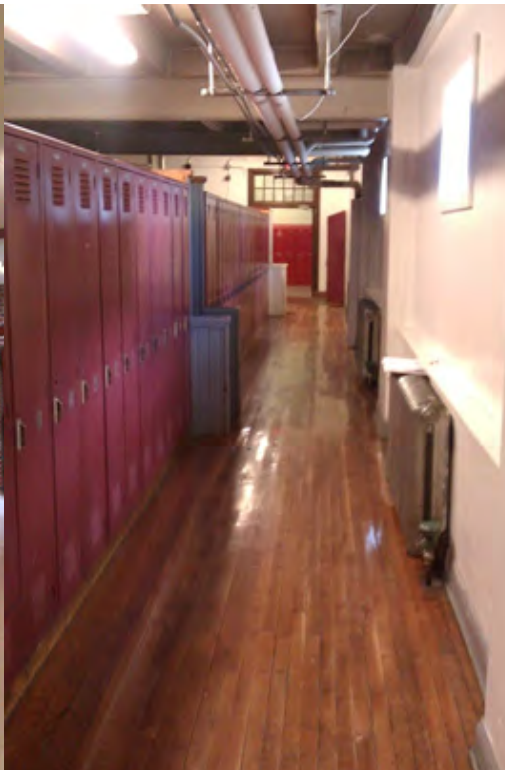
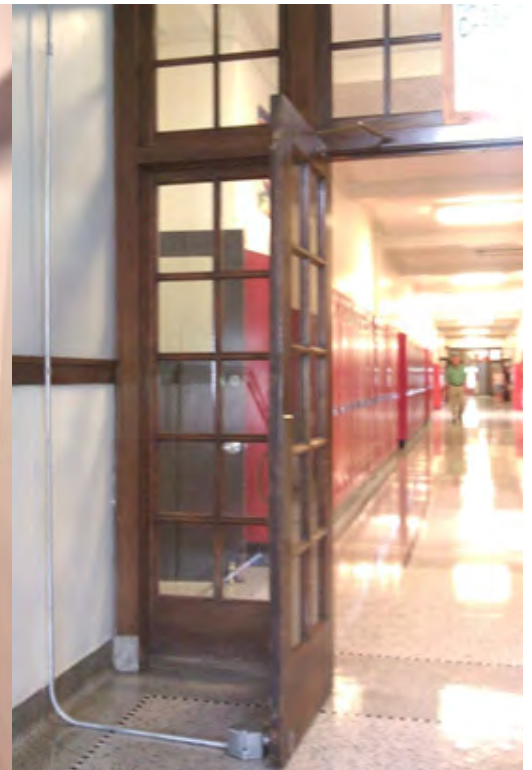
Terrazzo flooring is in very good condition in many locations. Wood flooring needs attention. (Bottom middle and right images)

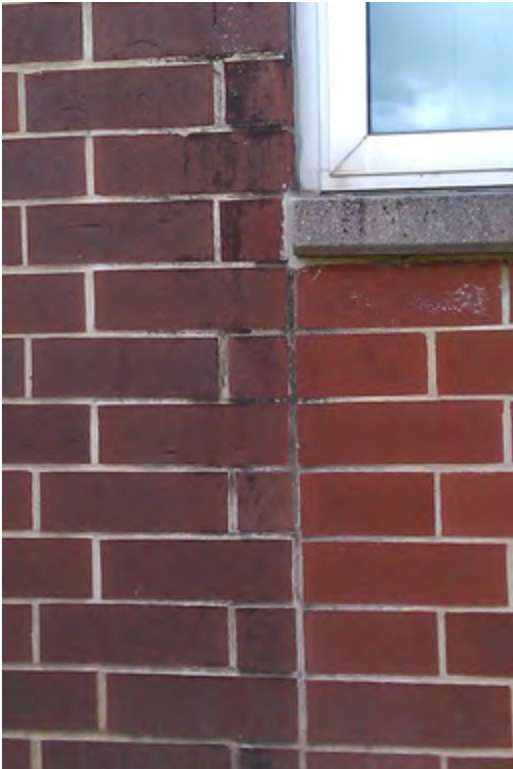
Caulking:
Sealant work should be carefully applied so that infiltration moisture is allowed to escape the building at window heads, sill frames and masonry weeps. Improper sealant can capture. (Top left image)

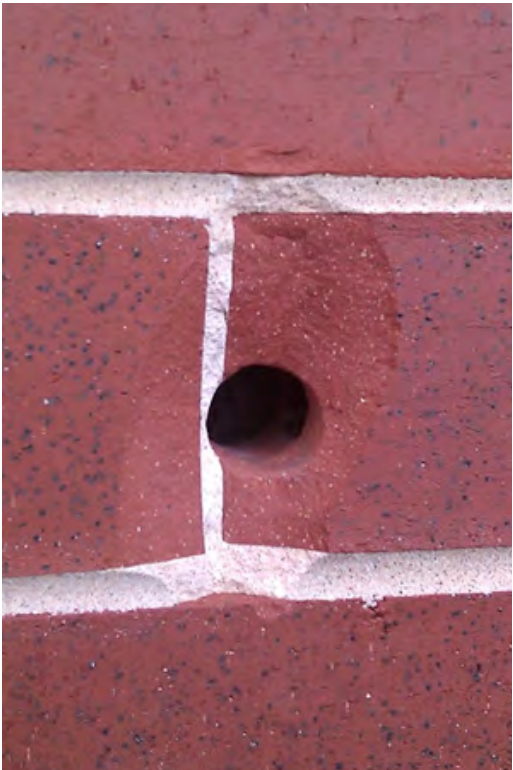
Masonry:
The exterior masonry of this building shows efflorescence around the entire perimeter. It is under window sills, flashing, limestone sills and at mortar joints in general. This condition is evidence that moisture is getting into the building wall cavity and the brick itself. We understand that corrective measures have been taken, specifically adding flashing a couple courses down from the top of the wall. The deposits and staining should be removed to determine if the problem still exists. If the deposits reoccur that means there is still enough moisture getting into the wall that it can accelerate masonry wall decay and may even cause mold growth within the cavity or masonry cells.

Sometimes brick has a large amount of calcium in the clay and the efflorescence occurs for years as it gets wet and dries. If the condition continues it should be monitored to avoid major issues. There are also locations of settlement and holes that need to be repaired or filled. (Bottom left image as well as next three pages)

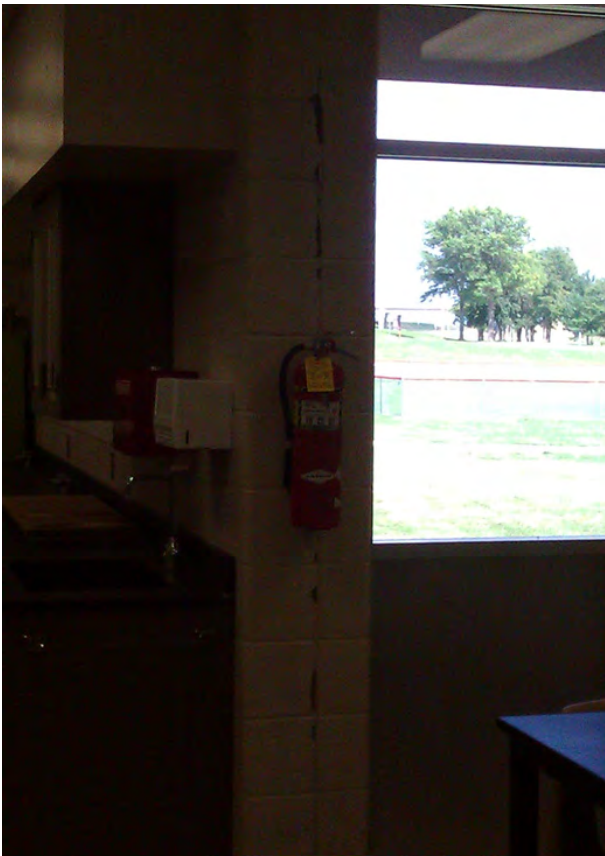
The crack and spalling on this interior CMU wall could have been caused by differential movement between the two walls. (Top left image)
