FACILITY ASSESSMENT REPORT

*MONTICELLO
COMMUNITY SCHOOL
DISTRICT*

FEH Associates Inc.
Architecture | Structural Engineering | Interiors

Monticello Community School District Facility Assessment

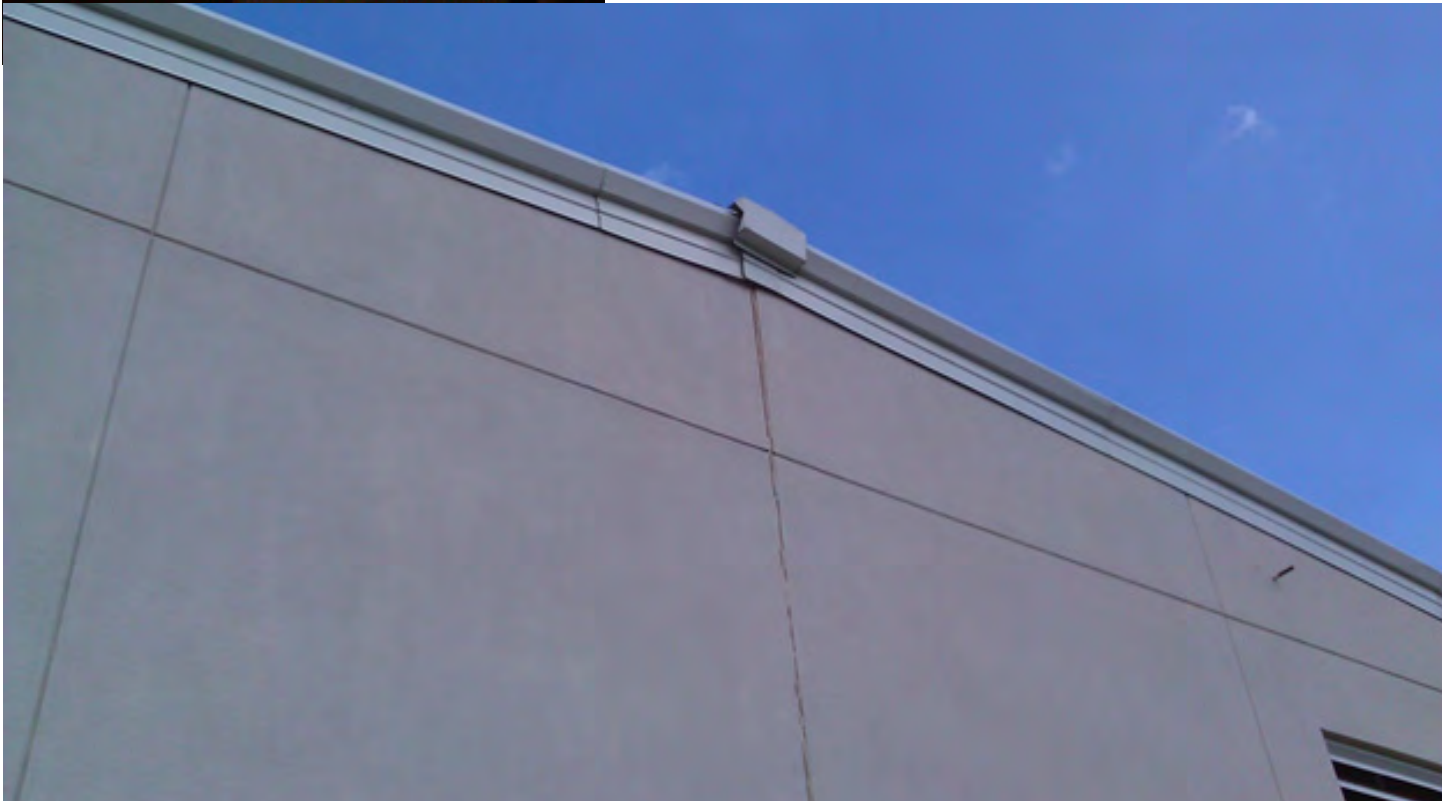
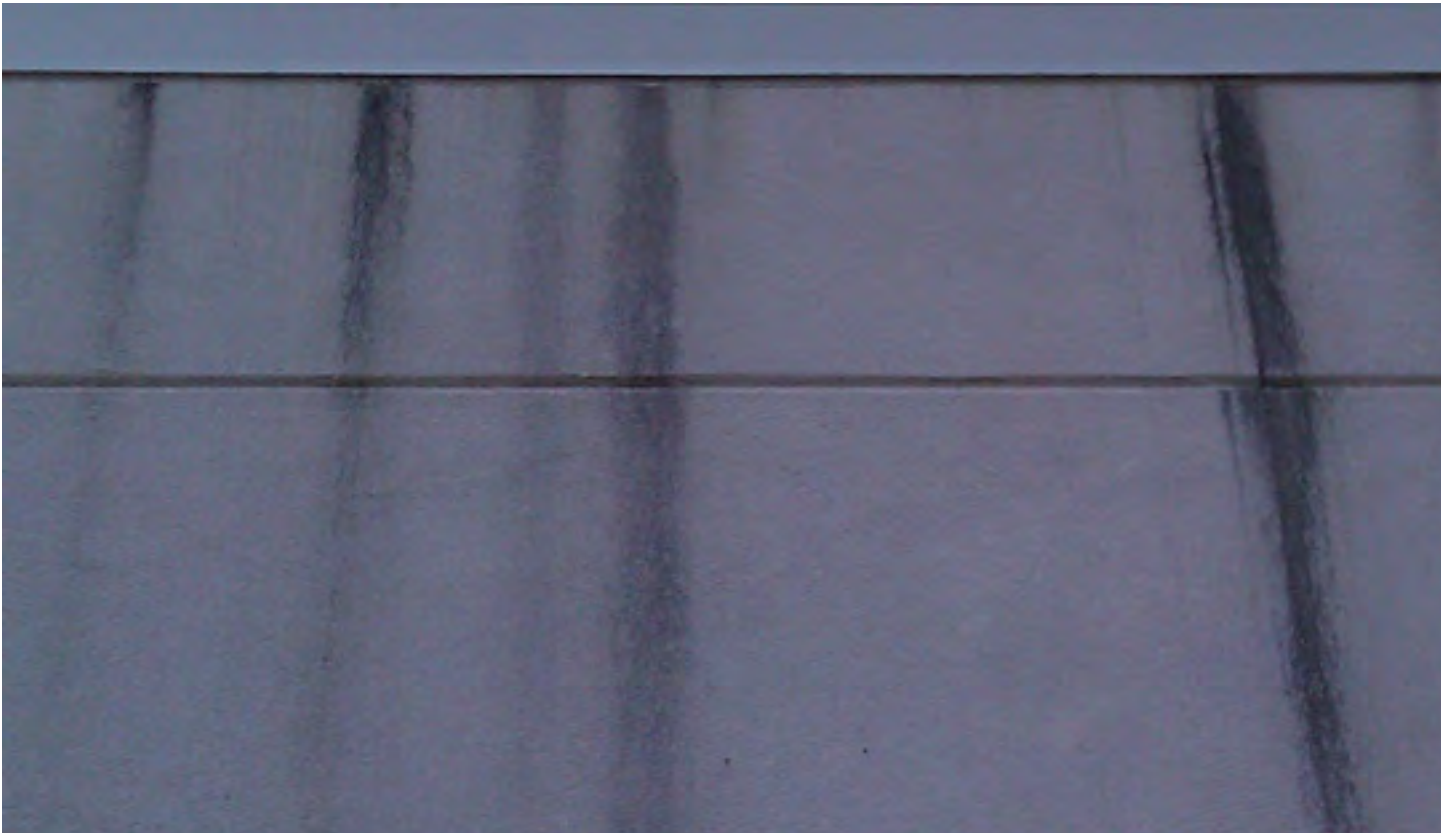
Walls:
The exterior walls are constructed of an EIFS product in many locations. This Exterior Insulation & Finish System has a history of problems and is not a preferred exterior finish for a building in your climate. (Bottom image this page and top image next page)

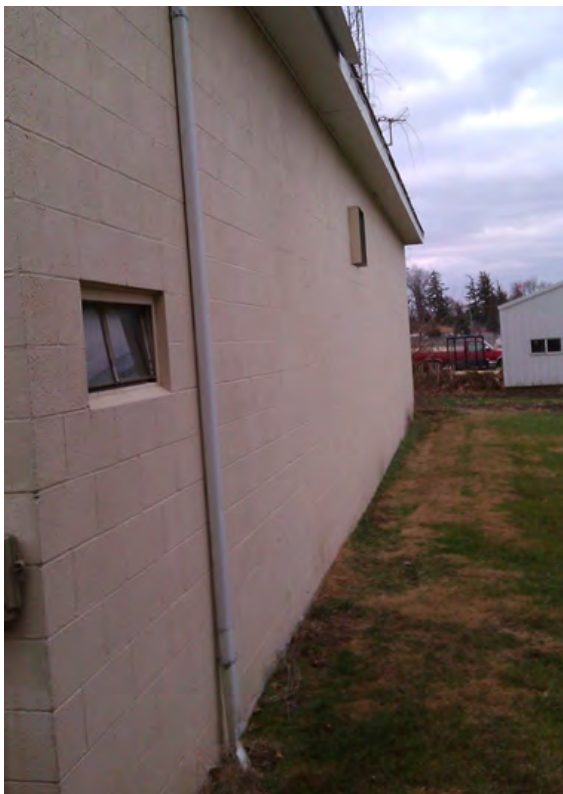
Masonry:
The building is primarily 8" x 16" concrete block without any insulation. There has been recent repair of the masonry of the garage structure. There are many locations where the masonry of the shed structure is damaged and causes structural concern. This appears to be a result of vehicle collision and some protection would be a good idea for improvement. (Bottom left image and Next page bottom image)

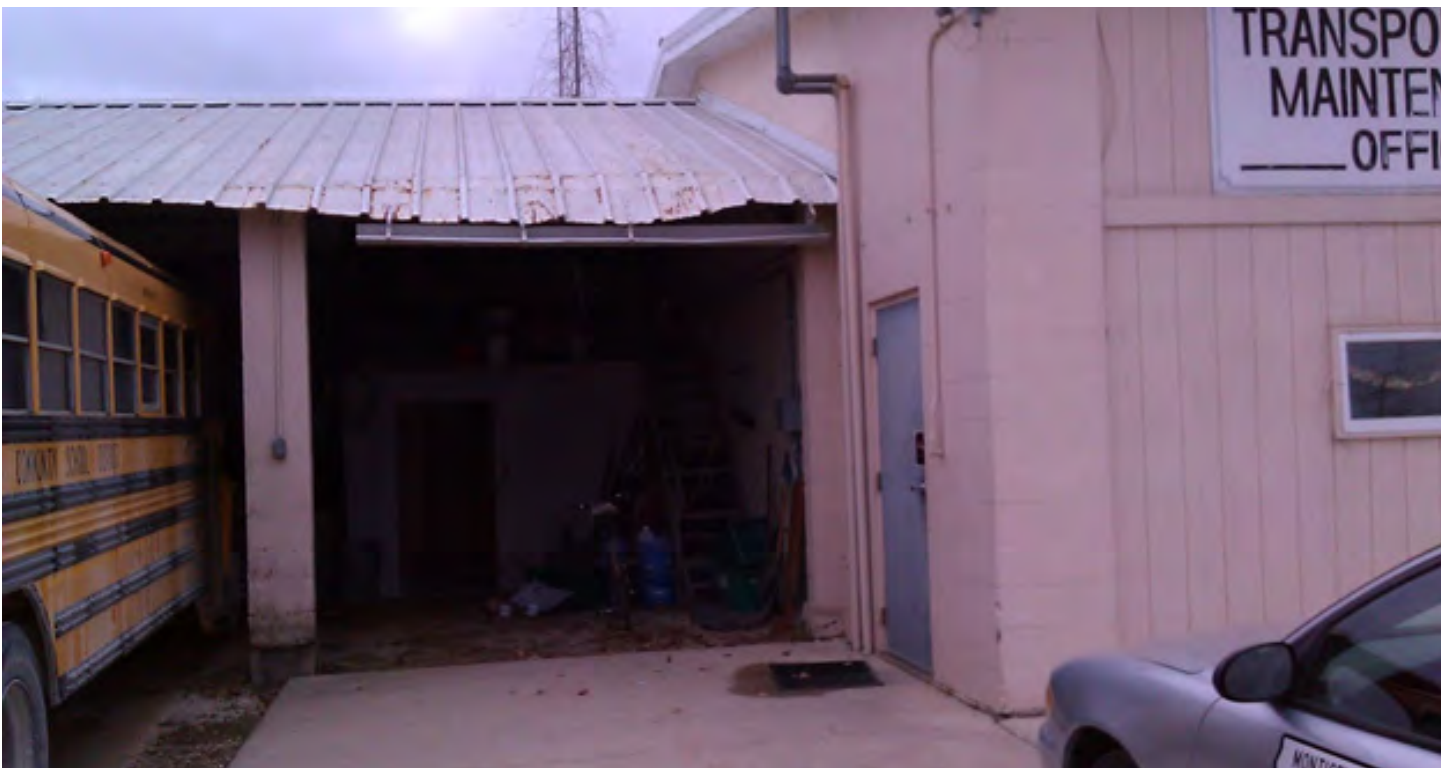
The open structure has several locations where the Concrete block walls require repair to avoid an unsafe condition. These issues do not appear to be a result of settlement but a result of collisions with the building itself. Bollards should be considered for protection of all the openings and walls.
