FACILITY ASSESSMENT REPORT

*MONTICELLO
COMMUNITY SCHOOL
DISTRICT*

FEH Associates Inc.
Architecture | Structural Engineering | Interiors

Monticello Community School District Facility Assessment

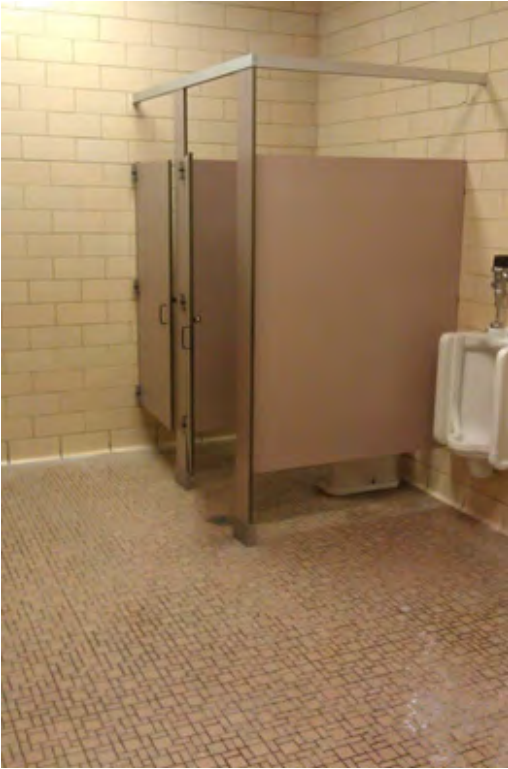
Restrooms:

The restrooms are not ADA compliant. Examples include 47" x 30" stalls and sinks without blade handles. (Top left image)

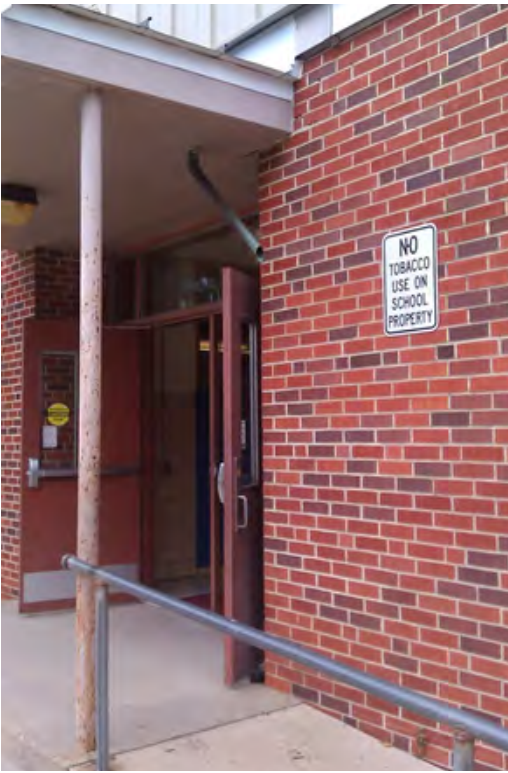
The north & south entry canopy downspouts both dump directly onto the ramps that were added. These have been roofed over more recently. (Left image)

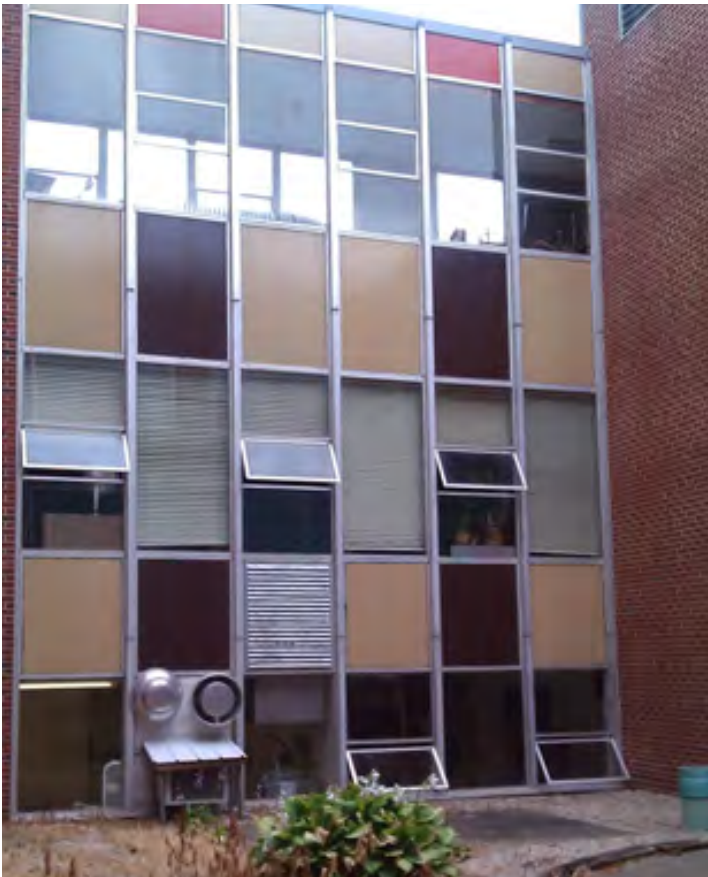
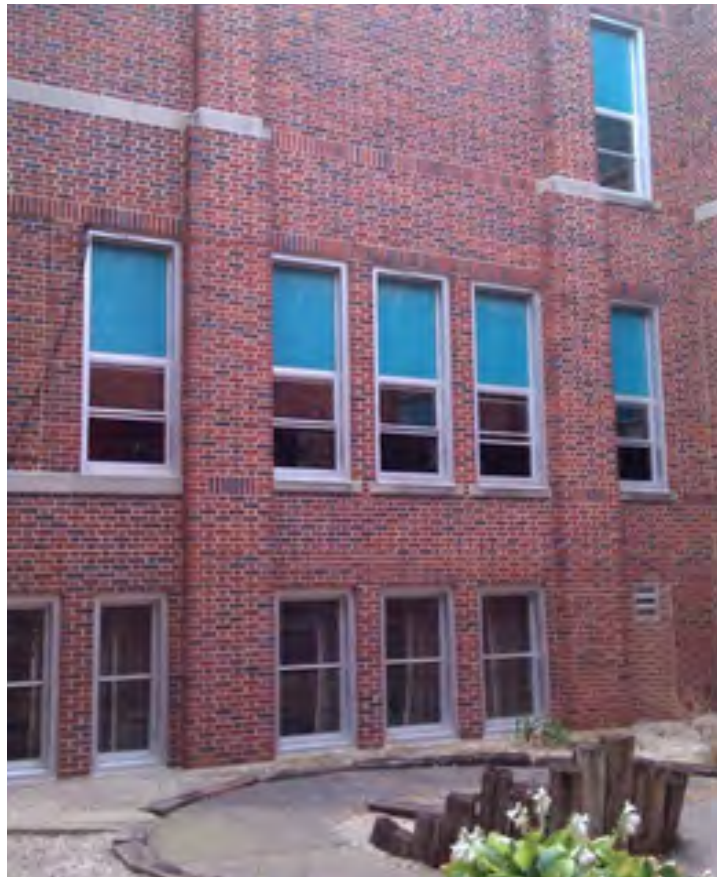
Windows:

There are locations where window panes are missing, Glass is broken, frames are rusted and glazing putty has broken away. (Top and left images)

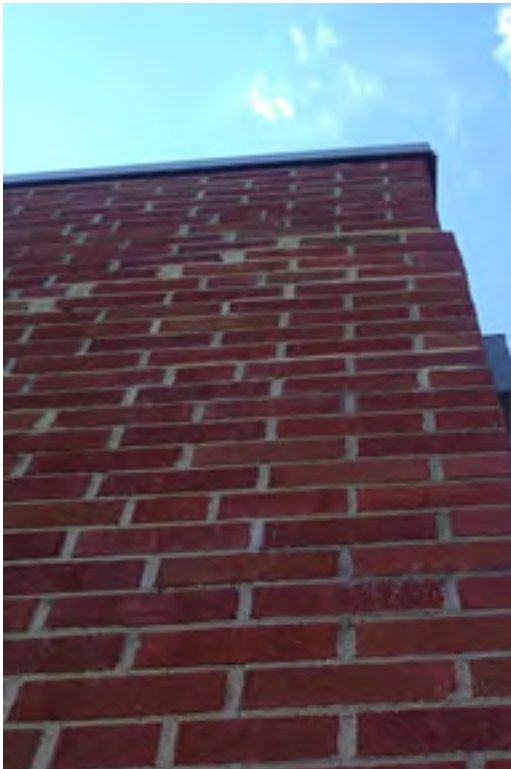
Masonry:

Exterior and interior wall materials are primarily brick and concrete block. There are varying degrees of masonry issues. While much of the masonry is sound there are several locations where settling and movement has occurred. Some of these locations appear to currently be shifting as evidence by opens in previously patched areas. There are areas of moss growth that should be remediated.

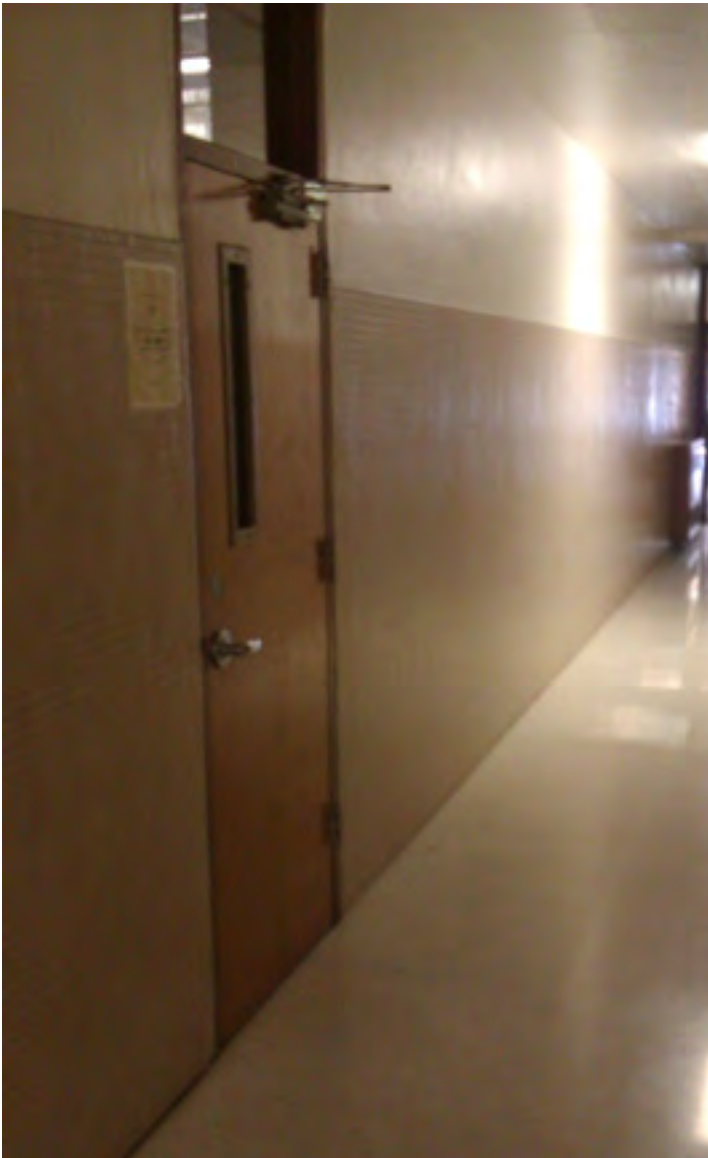
This door to the corridor from the classroom space swings into the corridor and not only reduces the required exit width but also is a hazard for people moving in the corridor. The main entry doors are too narrow to comply with current codes. (Top left image)

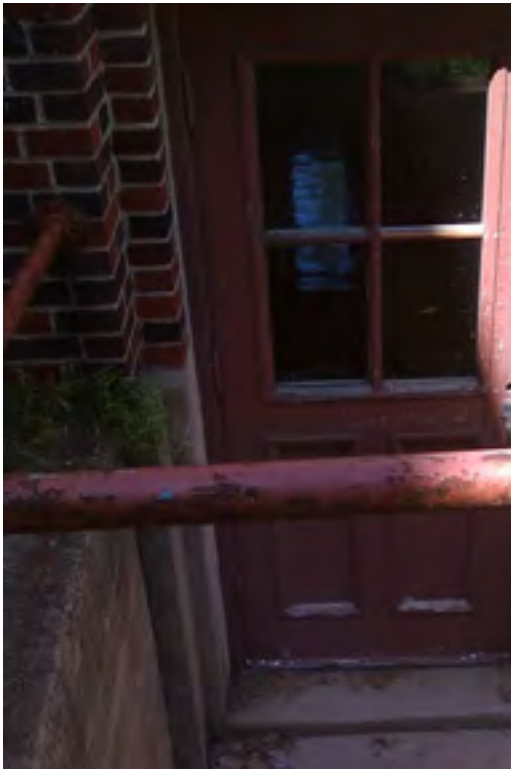
This old wood & glass door is a security concern. (Top Left Image)

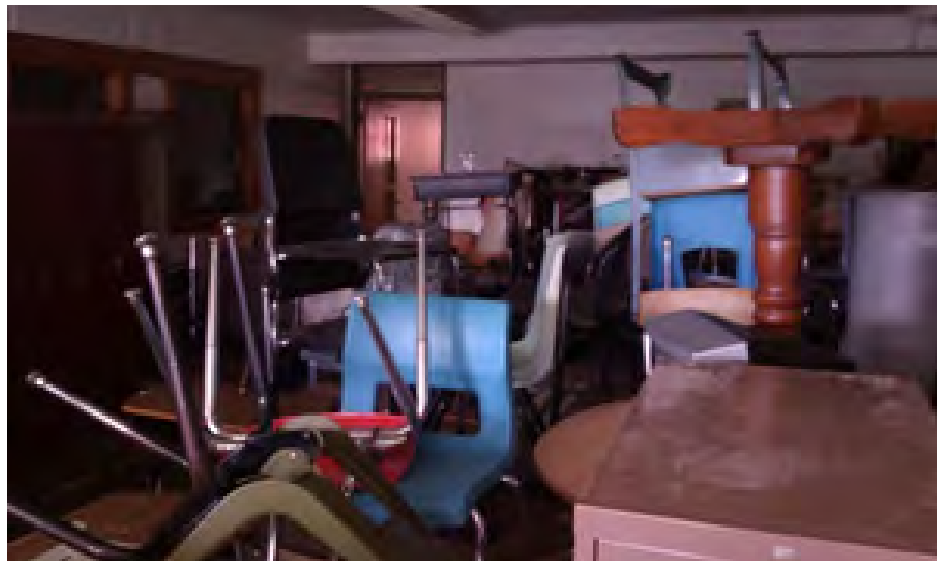
The State Fire Marshal's Office has cited the Middle school with numerous violations and ordered compliance. The inspection was conducted using the 2006 International Fire and Building Code. (Bottom image and on to the next page)

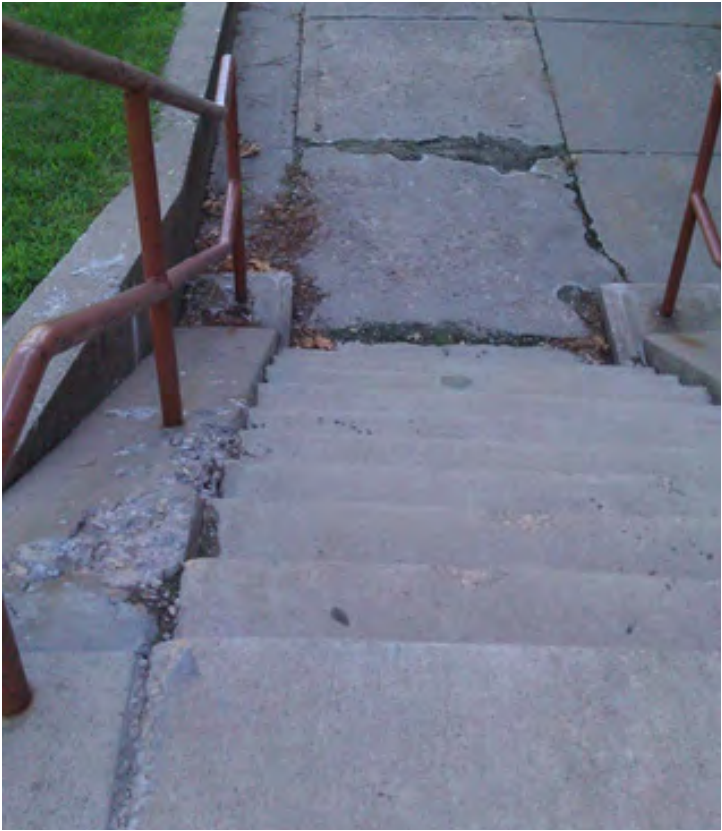
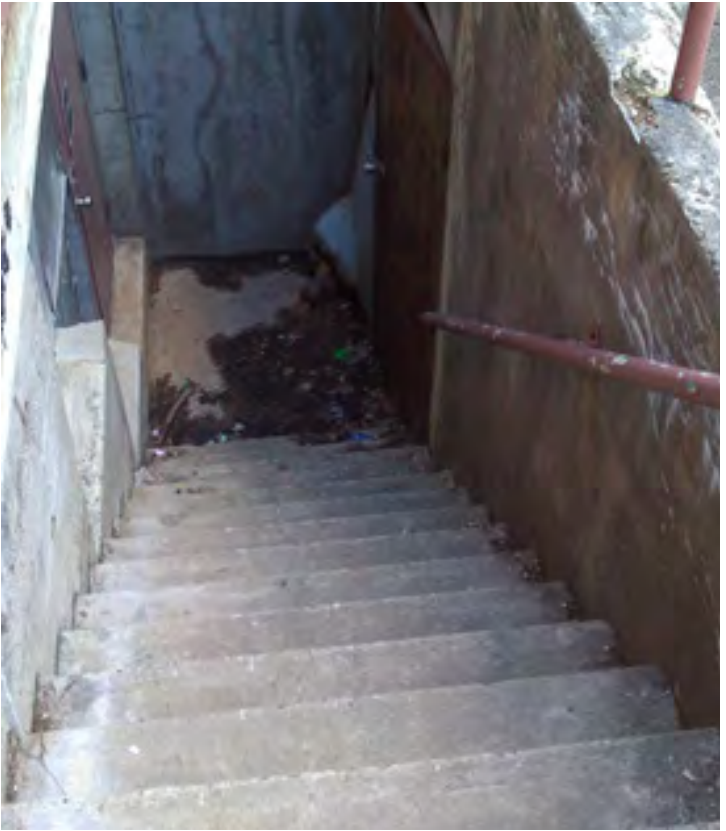
This building is a classic case of old multi-level buildings designed and constructed with no planning for universal access. Nearly every aspect of the building is in violation of codes and accessibility laws. Some examples are: entries, restrooms, stairs, elevator, handrails, drinking stations, dining, bleachers, classroom levels, stage, auditorium seating, computer lab, doorways. (Top left and right images as well as next page top and bottom images)

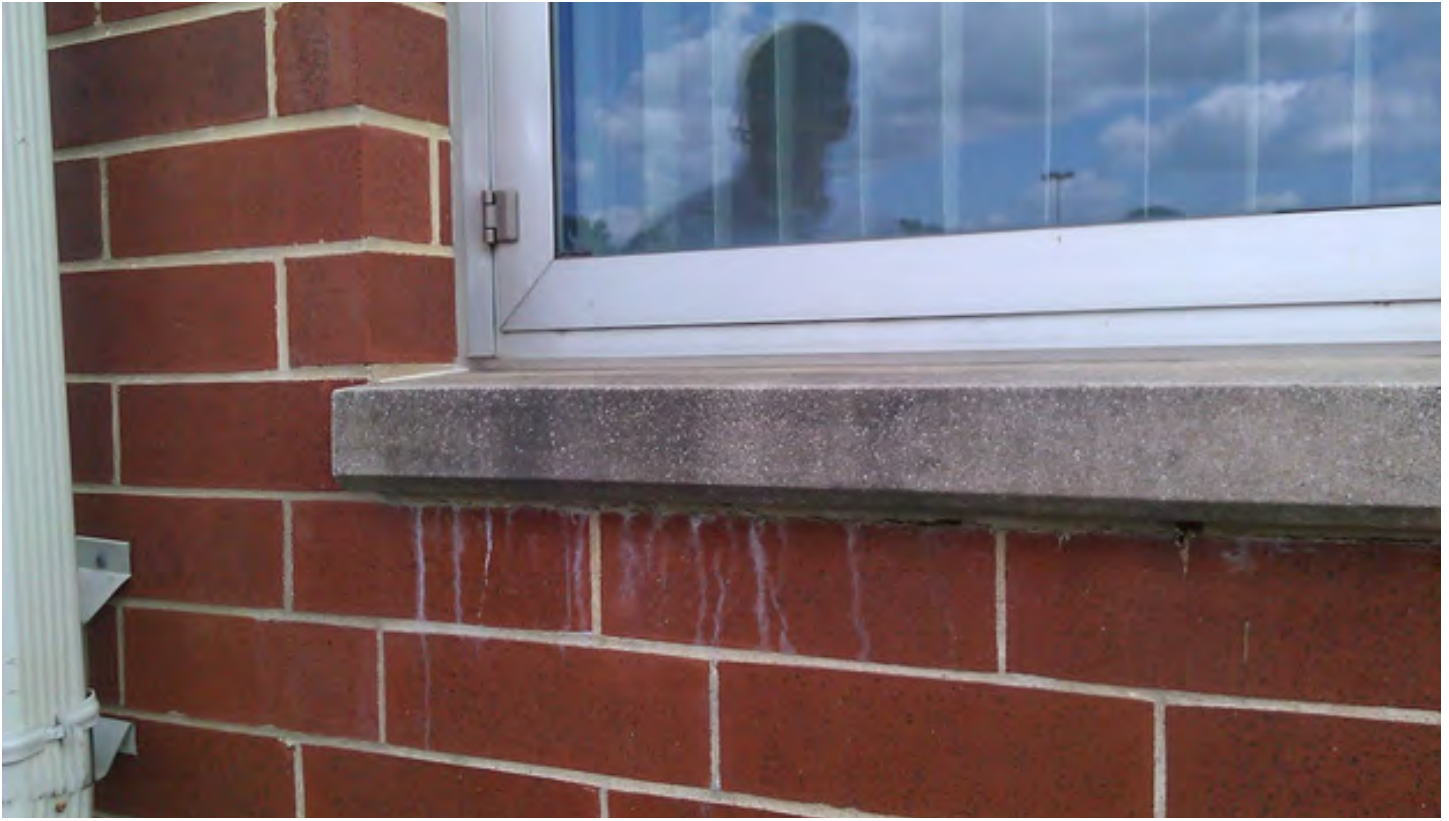
Caulking:
Sealant work should be carefully applied so that infiltration moisture is allowed to escape the building at window heads, sill frames and masonry weeps. Improper sealant can capture. (Top left image)

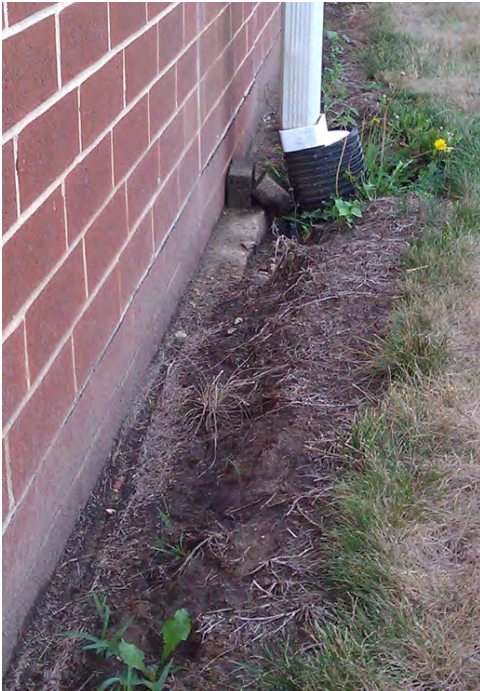
The structural systems appear to be in good condition except for the potential differential settlement noticed on the East side of the building and the areas where the site grade slopes toward the building. This may cause foundation settlement over time.

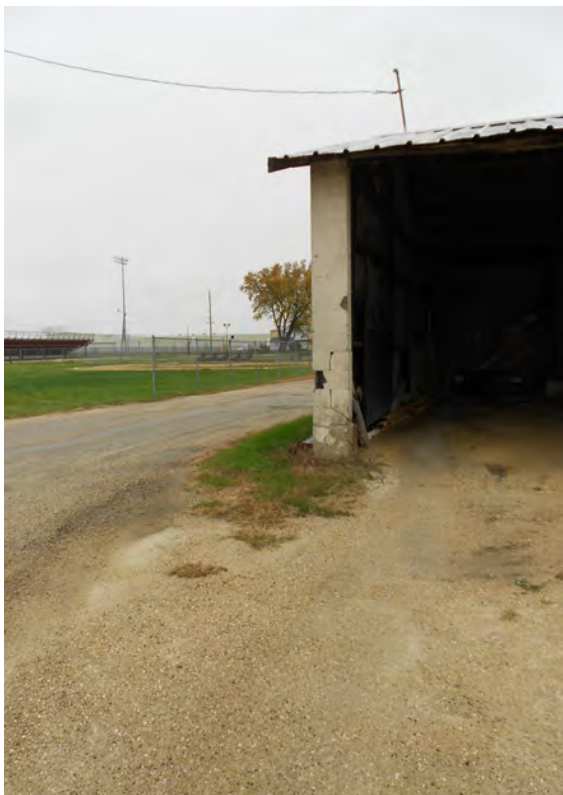
Masonry:
The building is primarily 8" x 16" concrete block without any insulation. There has been recent repair of the masonry of the garage structure. There are many locations where the masonry of the shed structure is damaged and causes structural concern. This appears to be a result of vehicle collision and some protection would be a good idea for improvement. (Bottom left image and Next page bottom image)

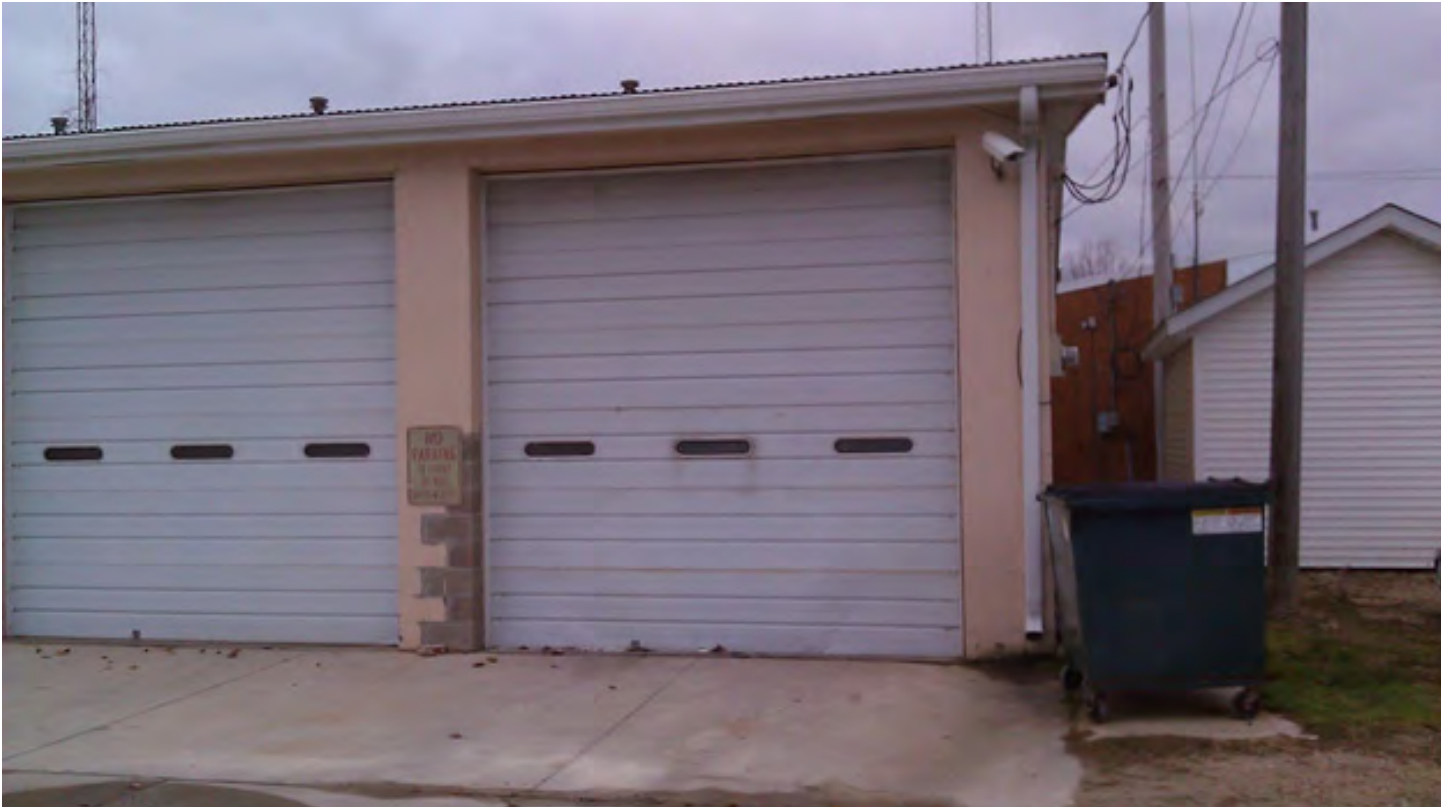
Doors:
The overhead doors show evidence of some damage from vehicles. The walk doors and hardware are worn and should be replaced. (Next page top image)

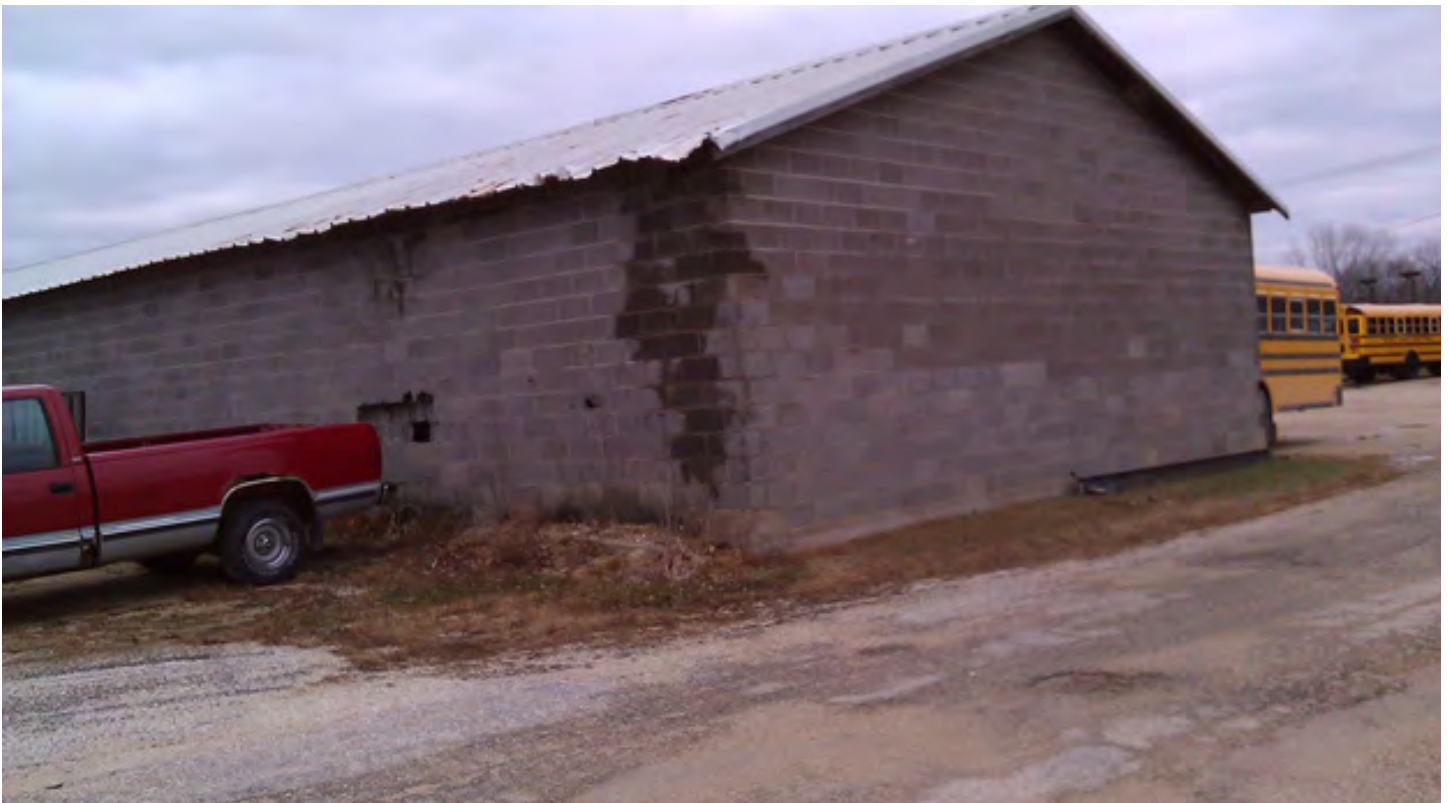
Numerous code issues are identified in the engineering and architectural sections of this report. This building is in the worst condition as it relates to health and life safety as any in the district. Though this facility does not house students these issues should be addressed soon. (Bottom image)
